# The Consequences of Operating EWPs on Soft Ground, Inclines and Unsupported Surfaces.

Elevating Work Platform Association of Australia Inc

[www.ewpa.com.au](http://www.ewpa.com.au) V1.0 issue May 2013

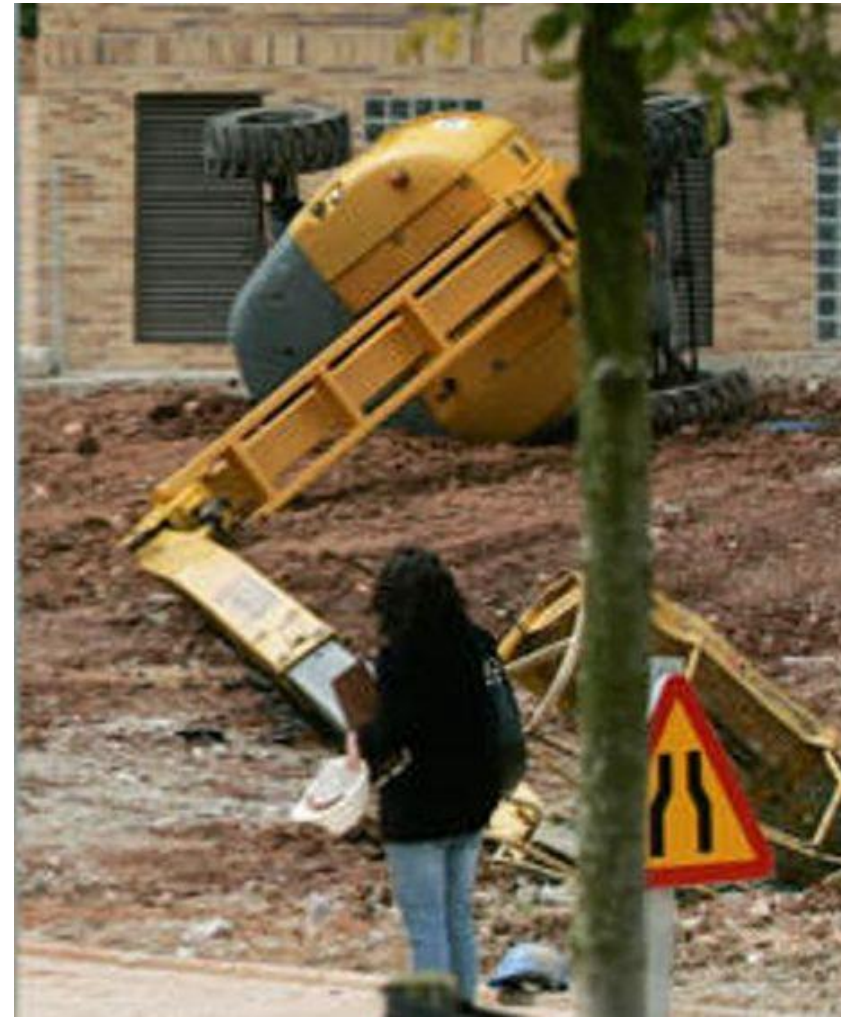
# Soft Ground. Fatality. Europe.

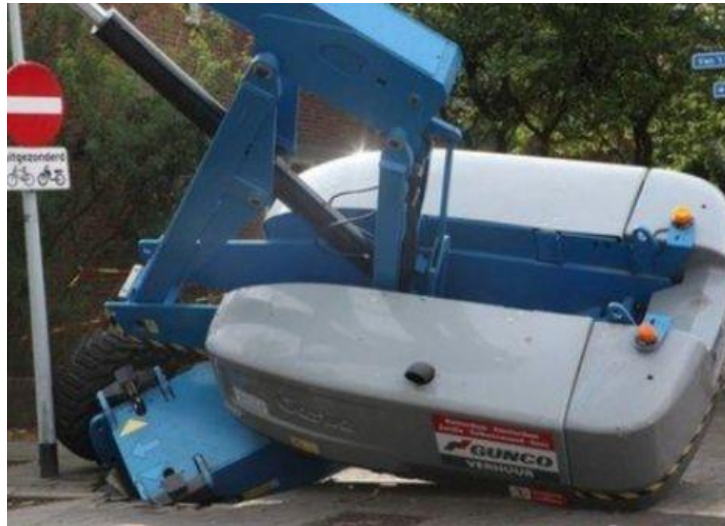
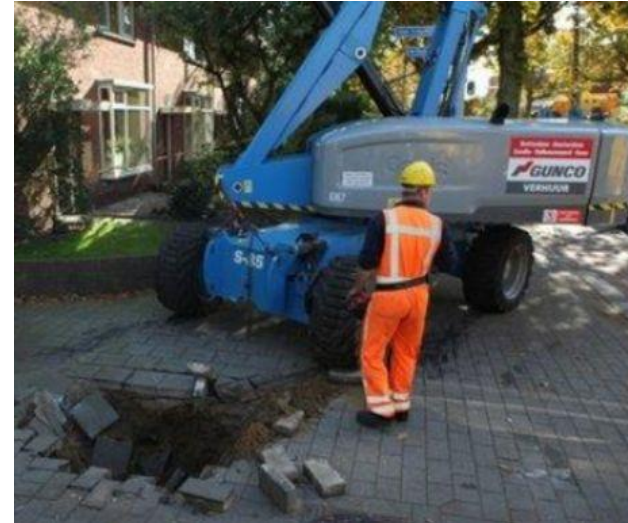
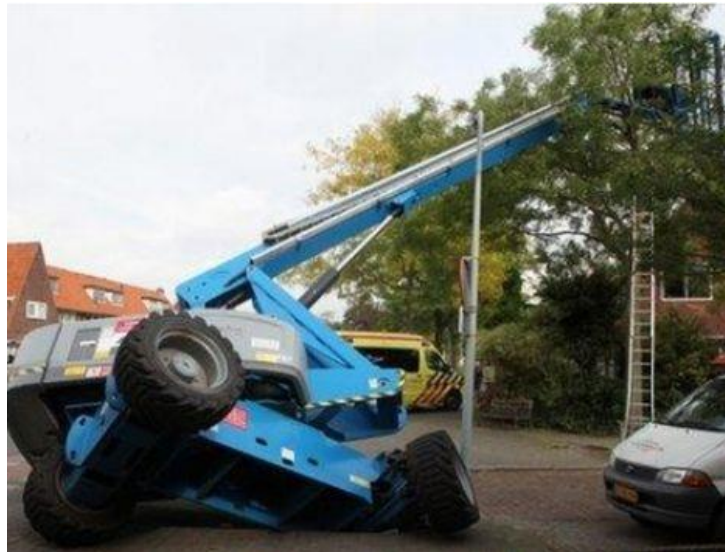
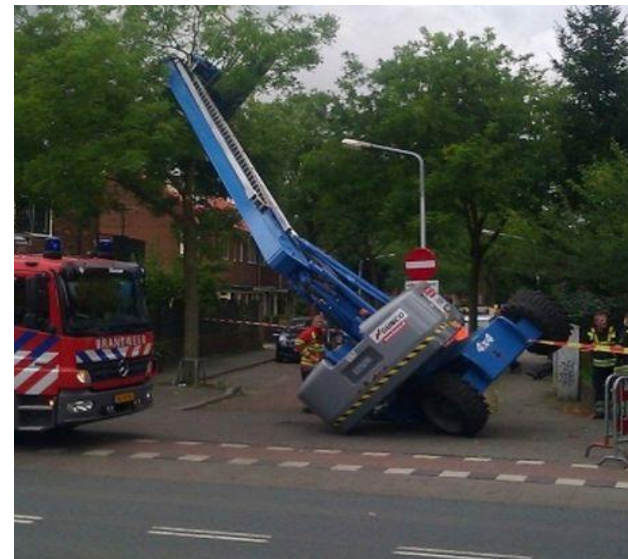
## Unsupported surface, Wheel into void. Rescued operator. Europe.

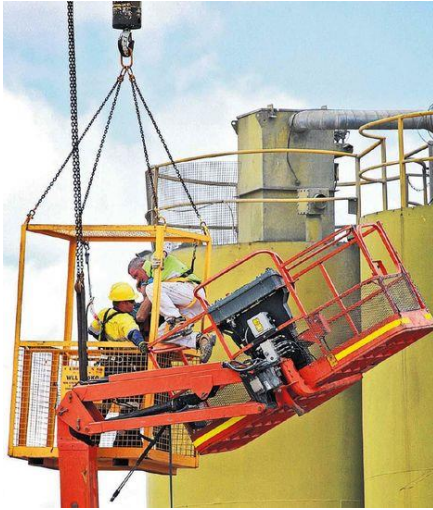
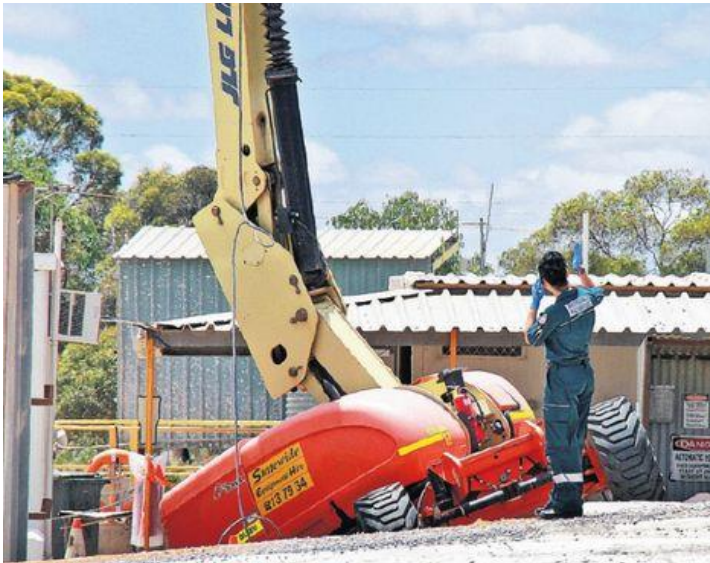
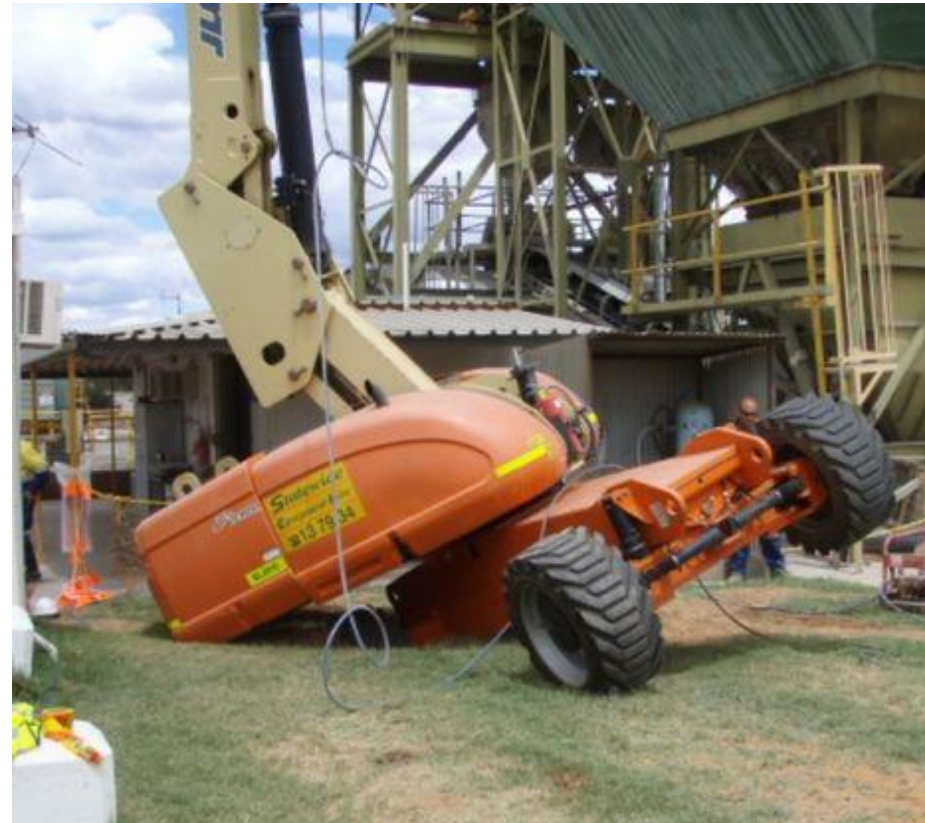
Broke through underground void,  
1 fatality from catapult effect, other  
operator rescued. Australia.

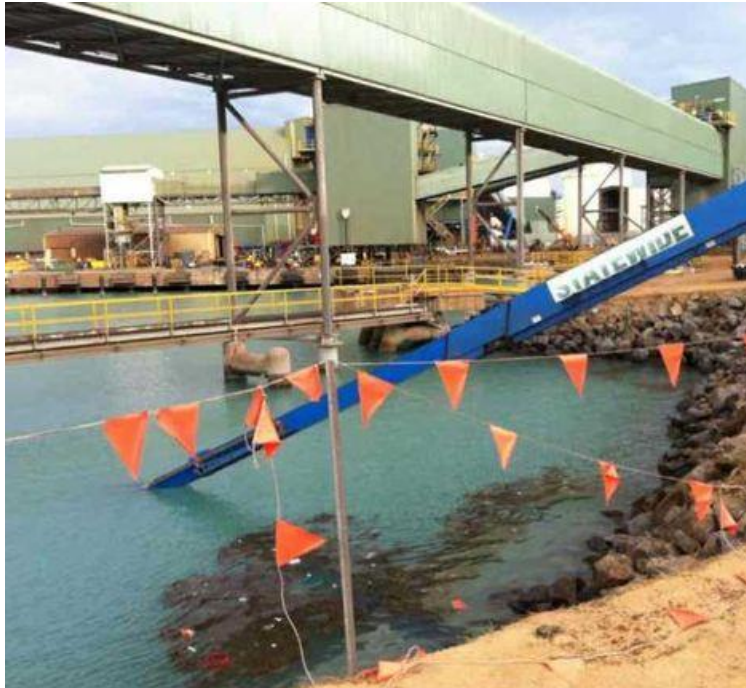
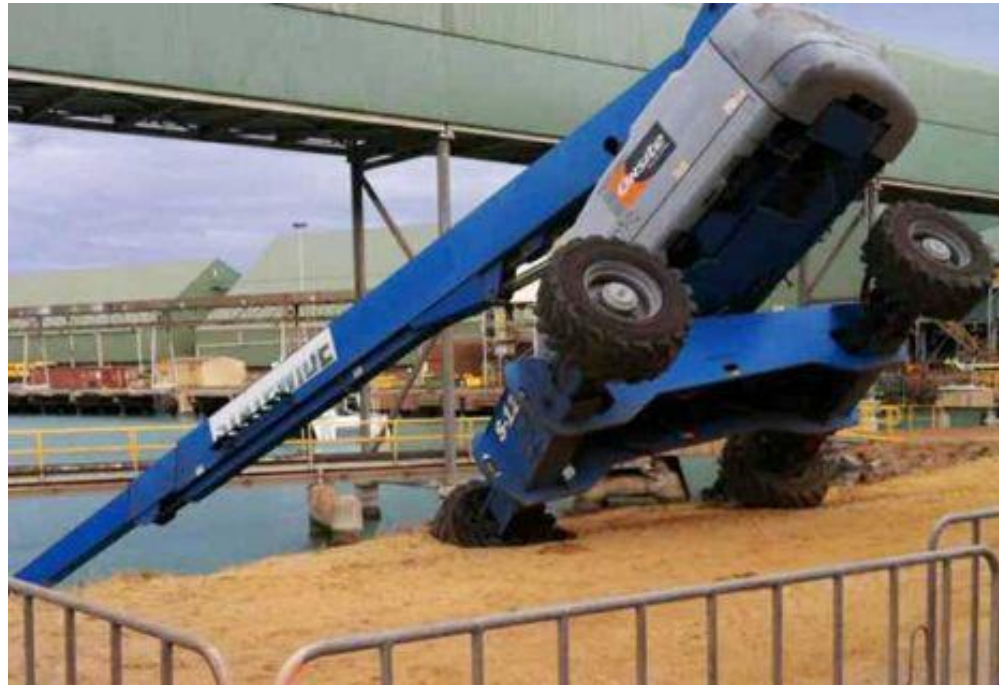
## Soft sand unable to support load. Two into the water, Australia.

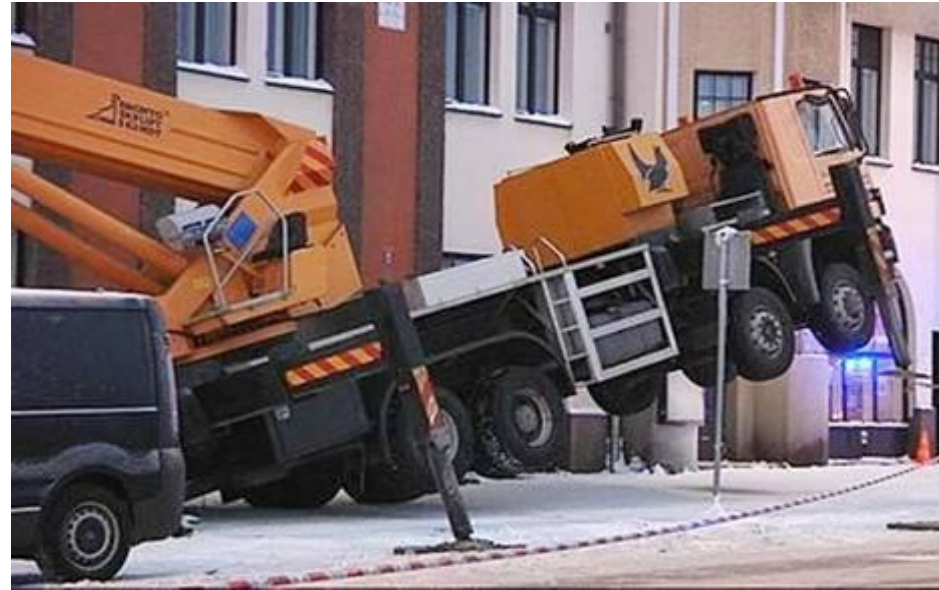
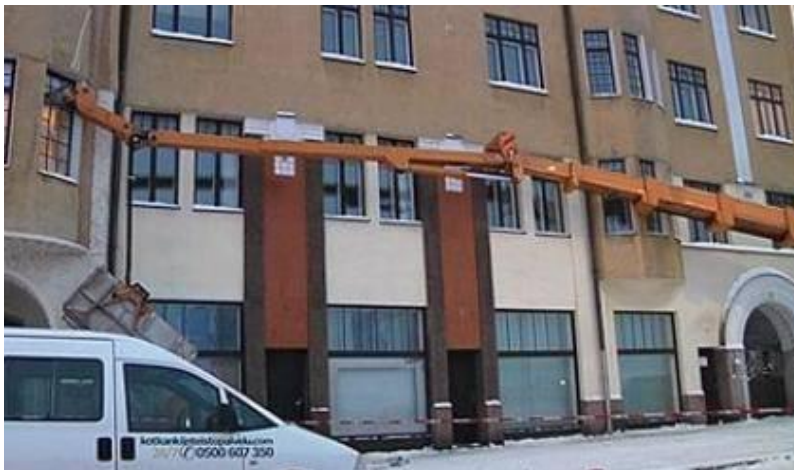
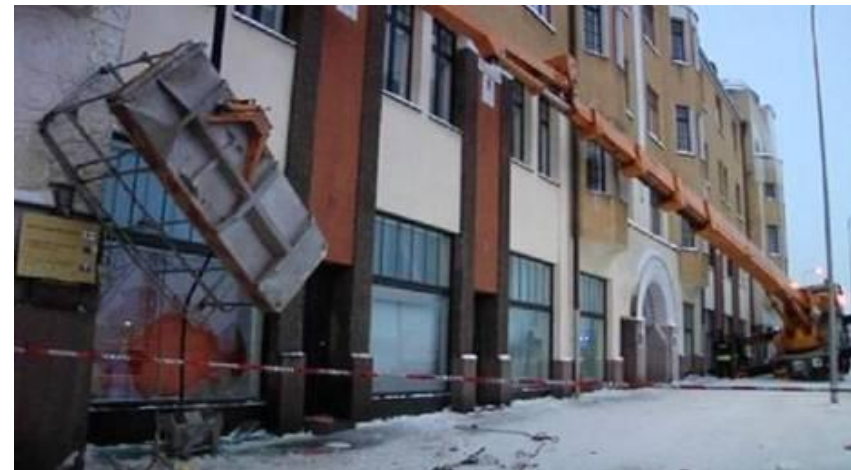
Support surface  
collapsed under  
outrigger.  
2 fatalities.  
Europe.

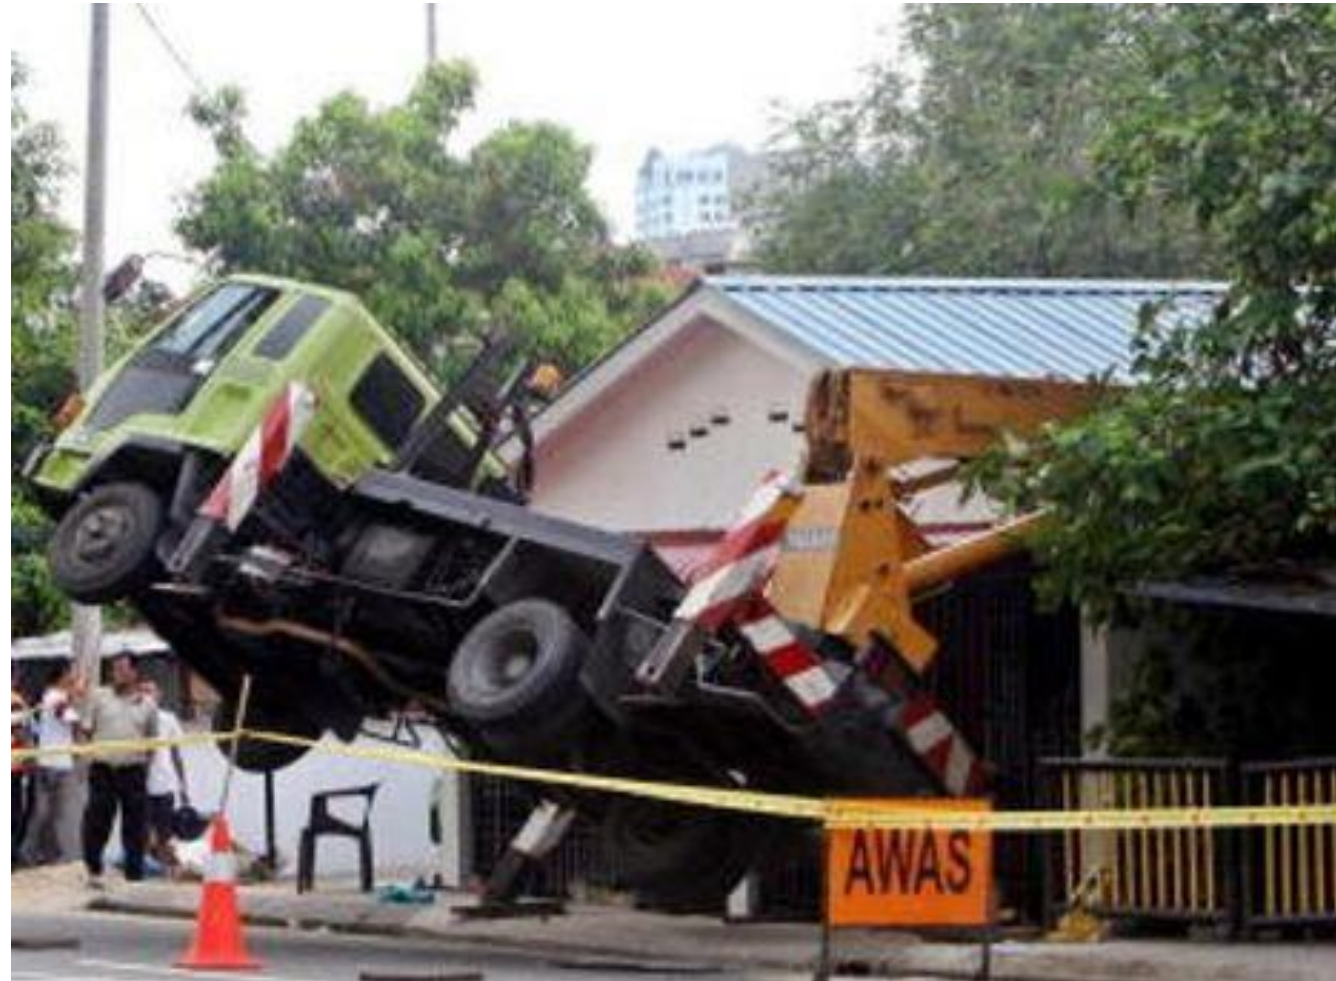
# Soft ground under outrigger. Fatality. Asia.

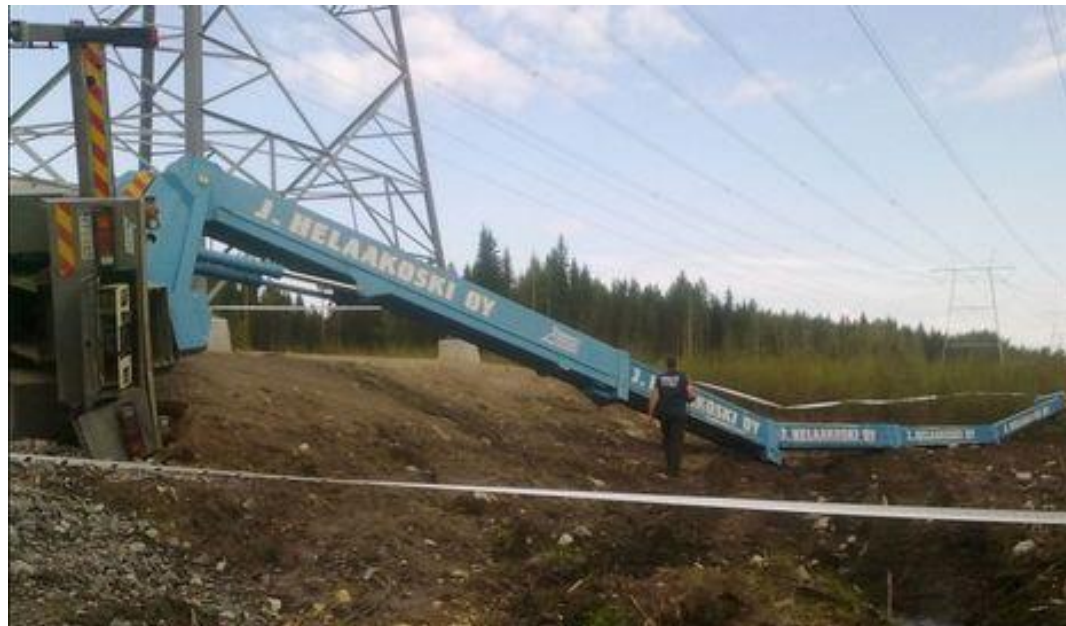
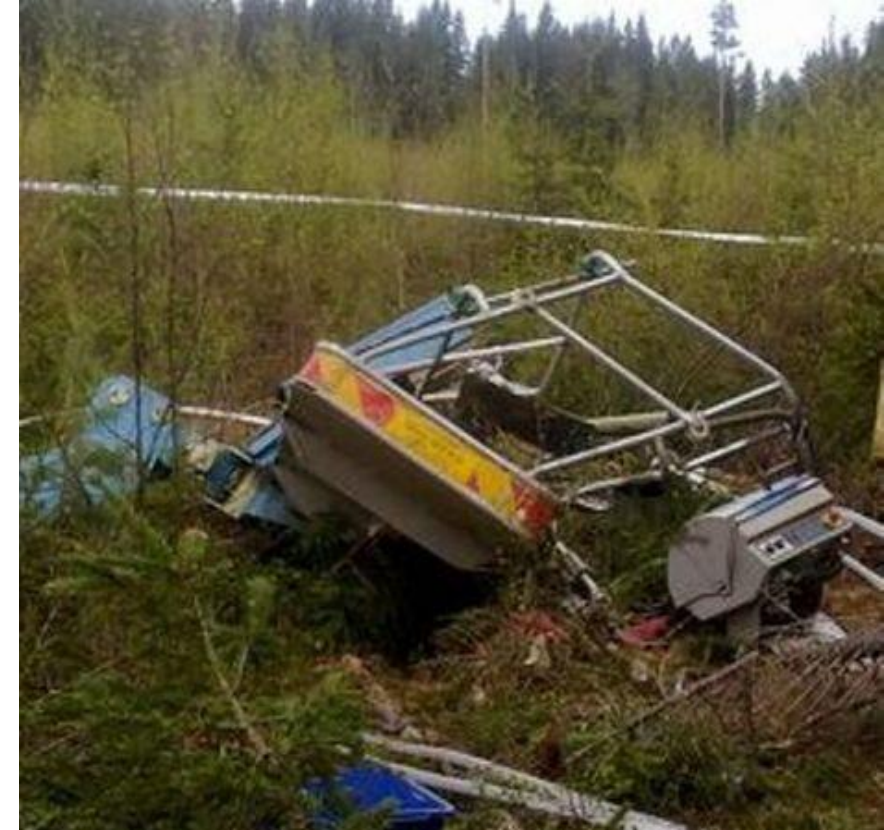
Soft ground  
under outriggers.  
3 injured.  
Europe.

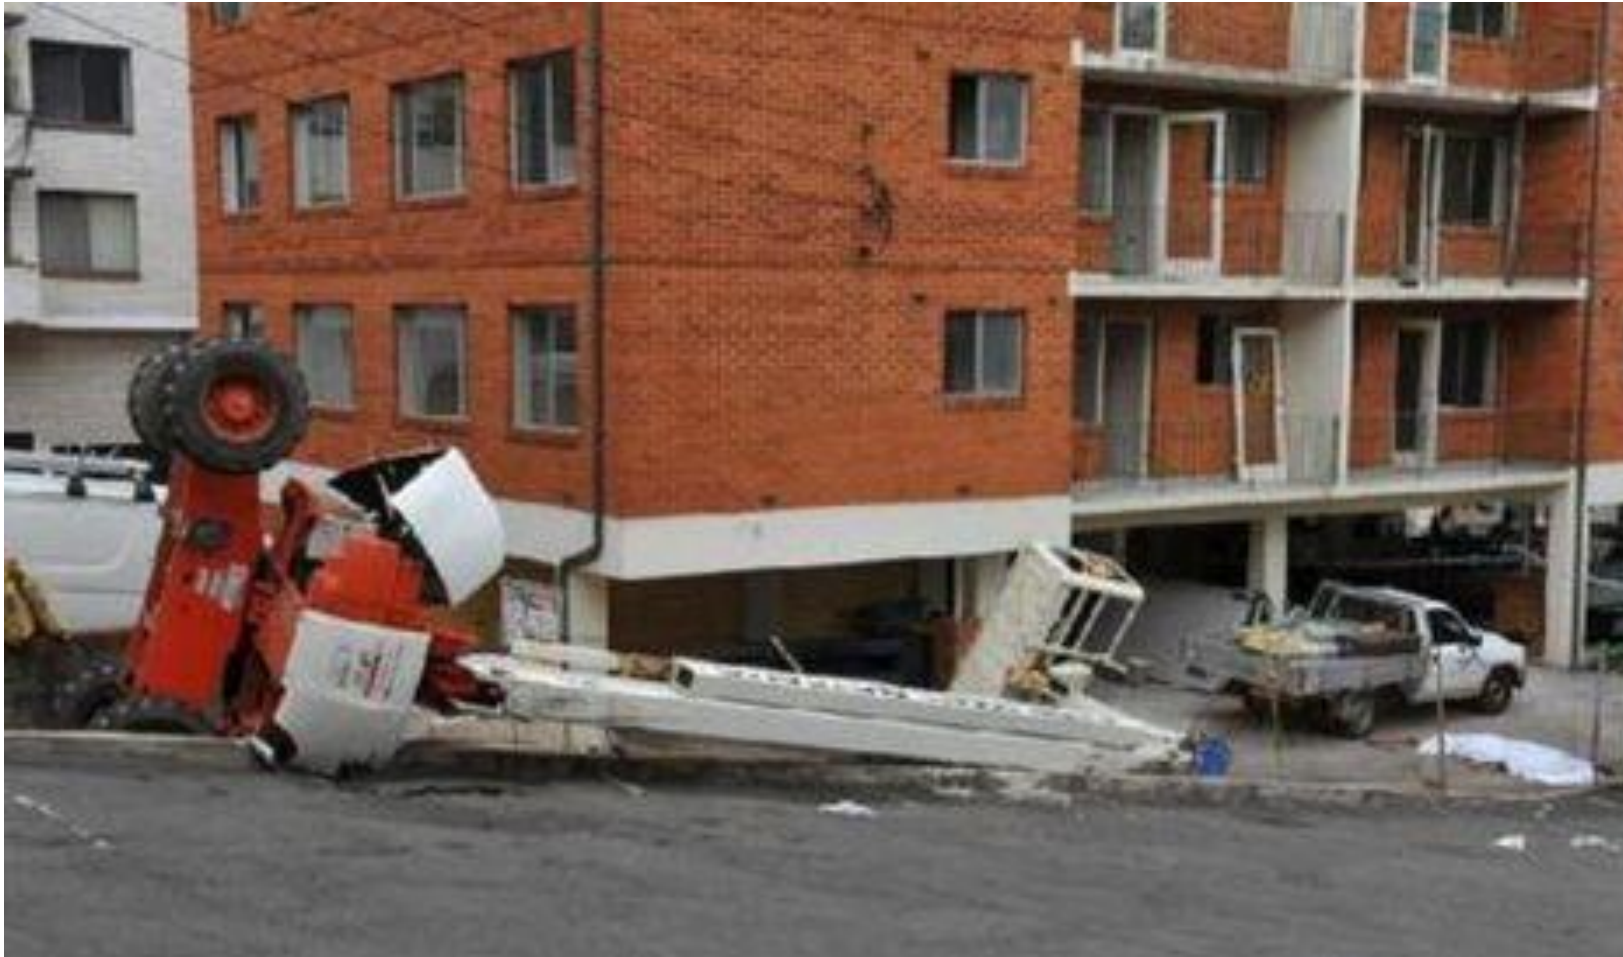
## Excessive backward incline. Fatality. Australia.

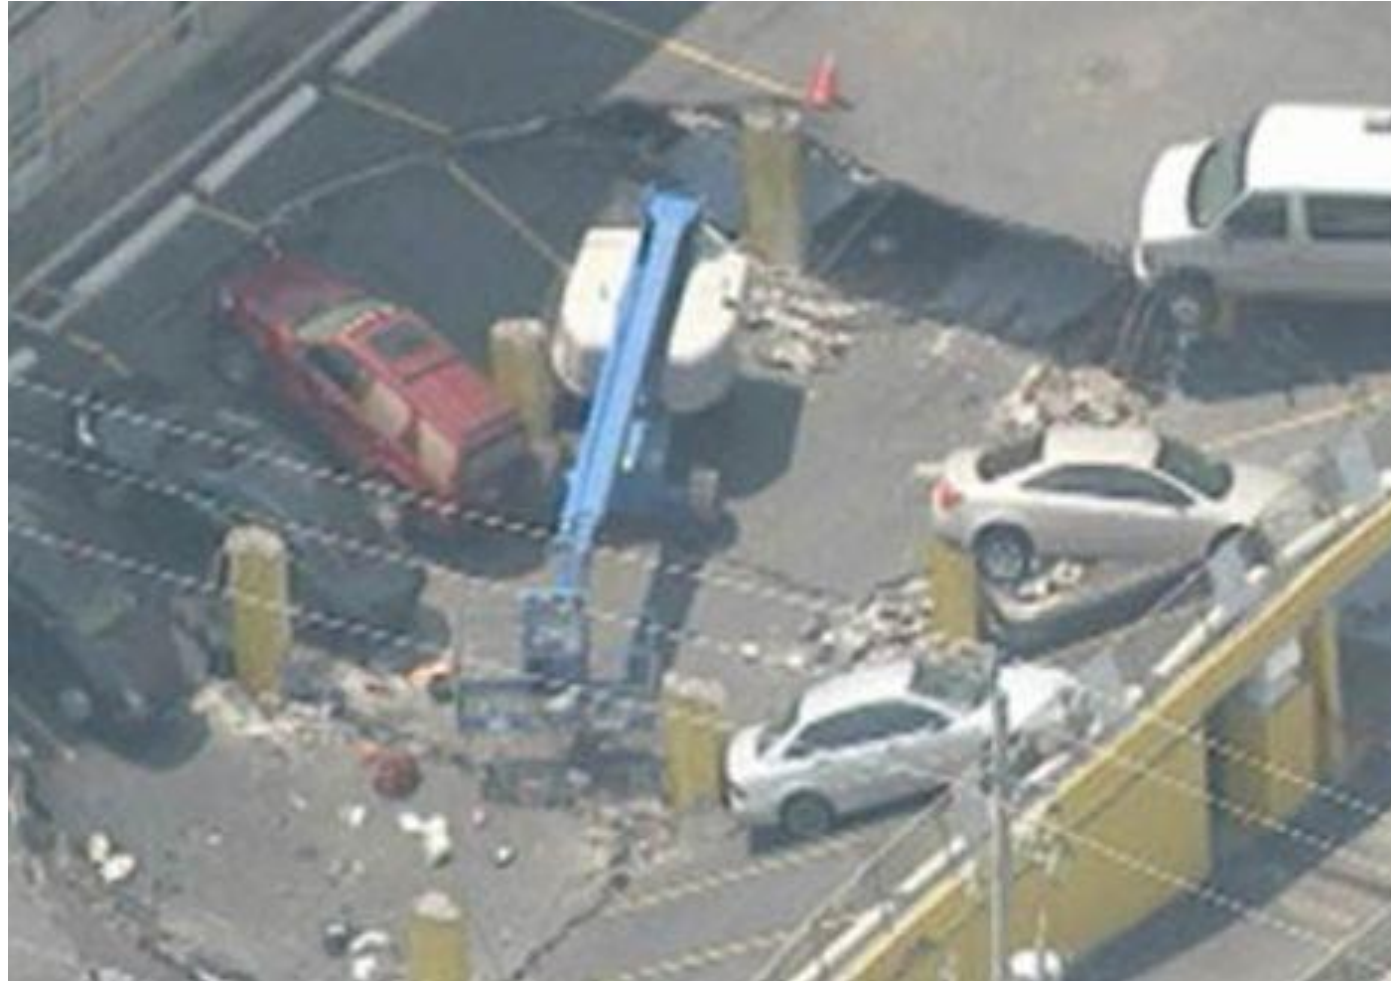
## Floor load exceeded, structural collapse of carpark. USA.

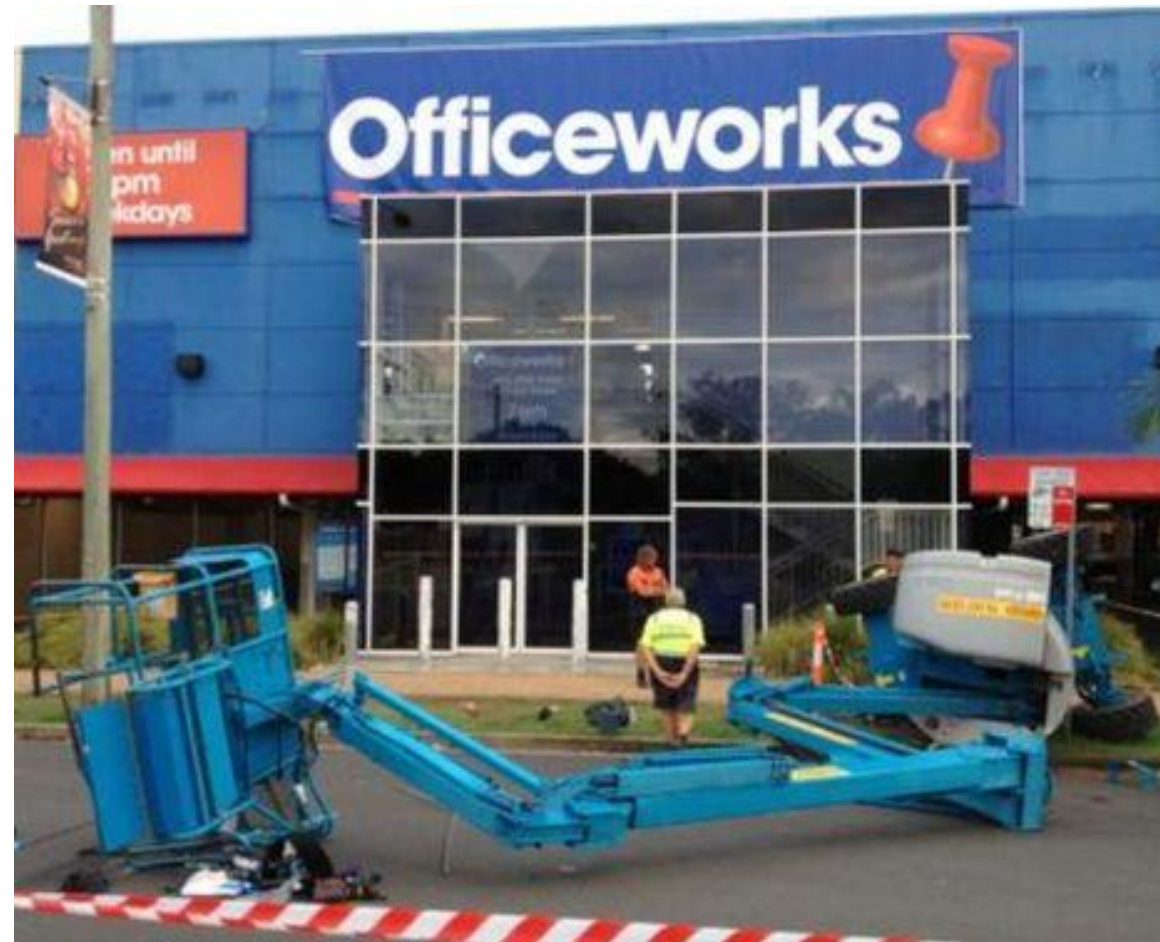
# Wheel through steel grating. Two injured, Australia.

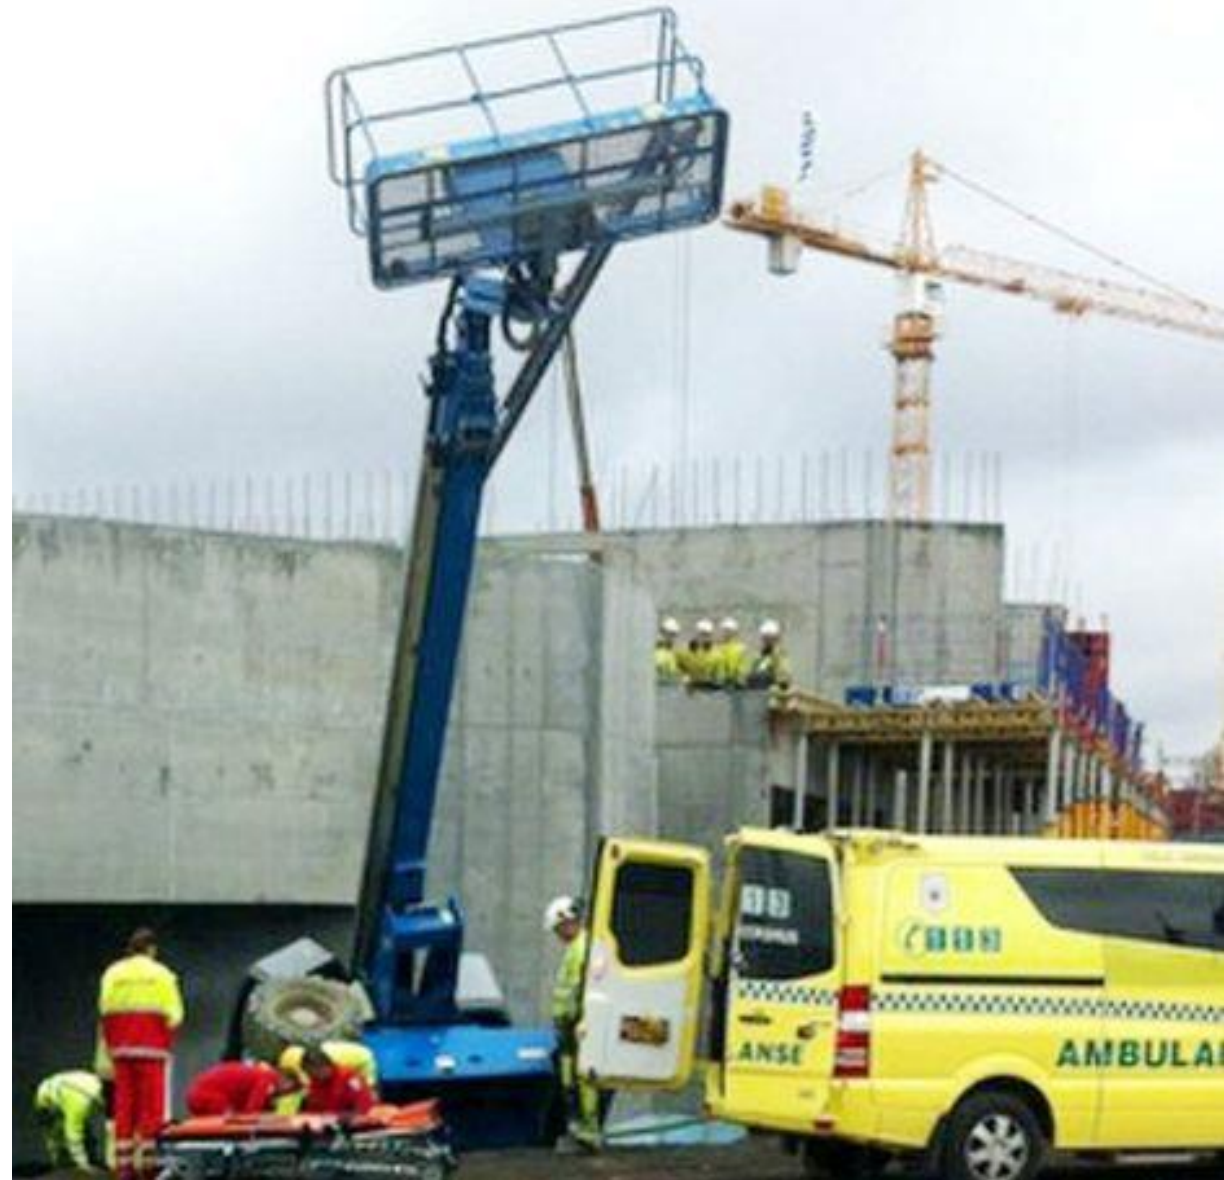
# Soft Ground. Catapult effect. Injuries. Europe.

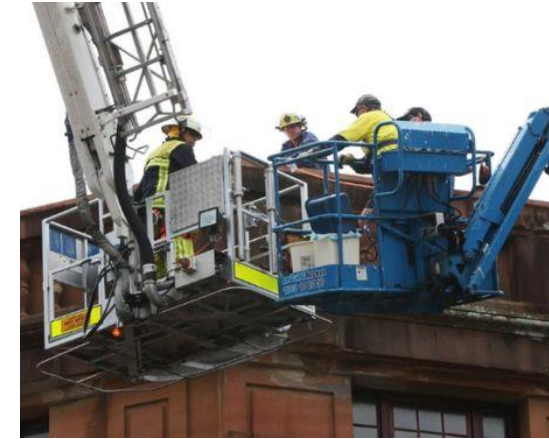
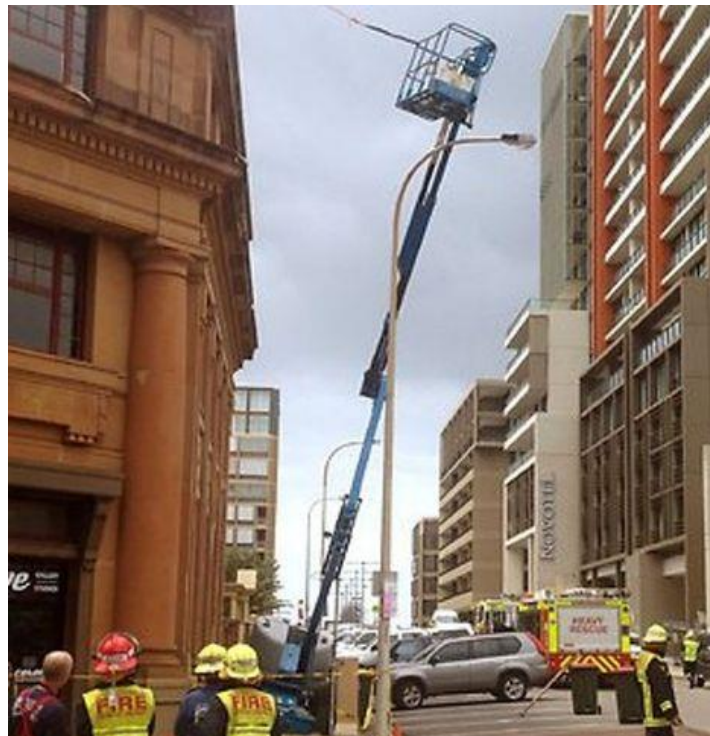
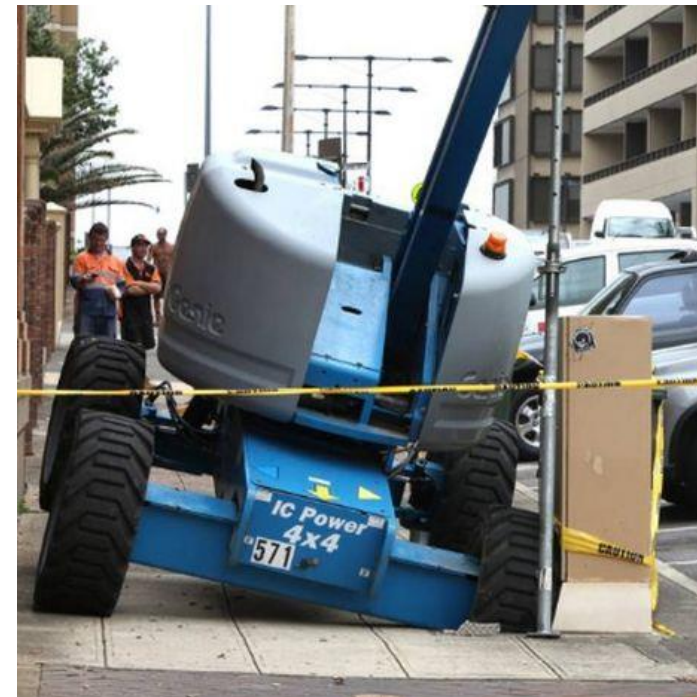
# Culvert collapsed. Operators rescued. Australia.

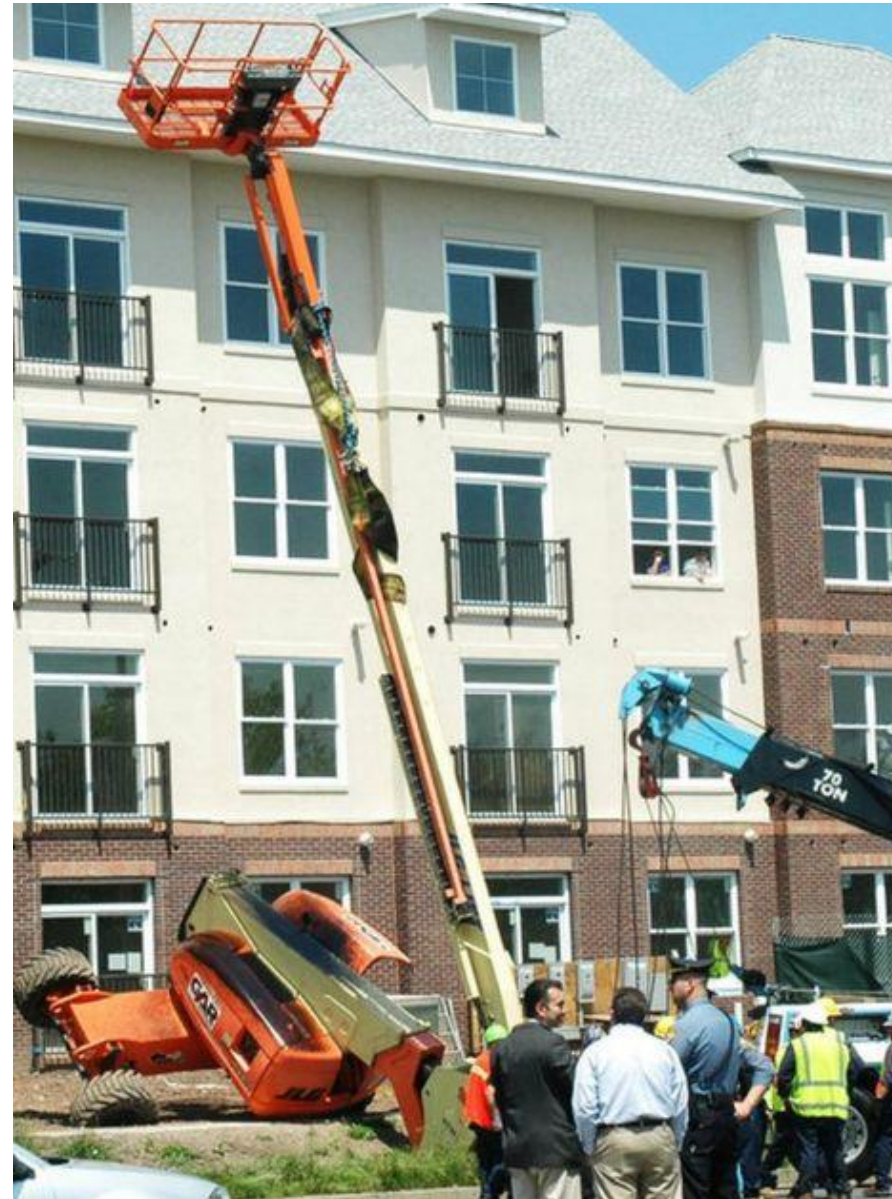
# Soft ground. Catapult. Fatality USA.

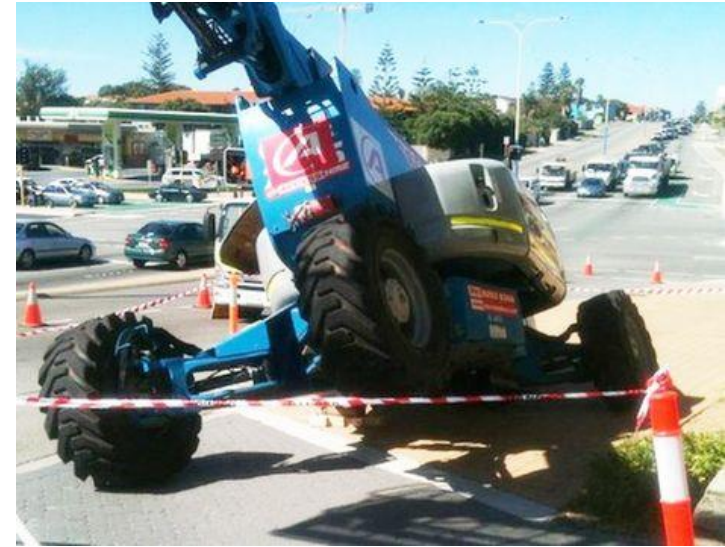
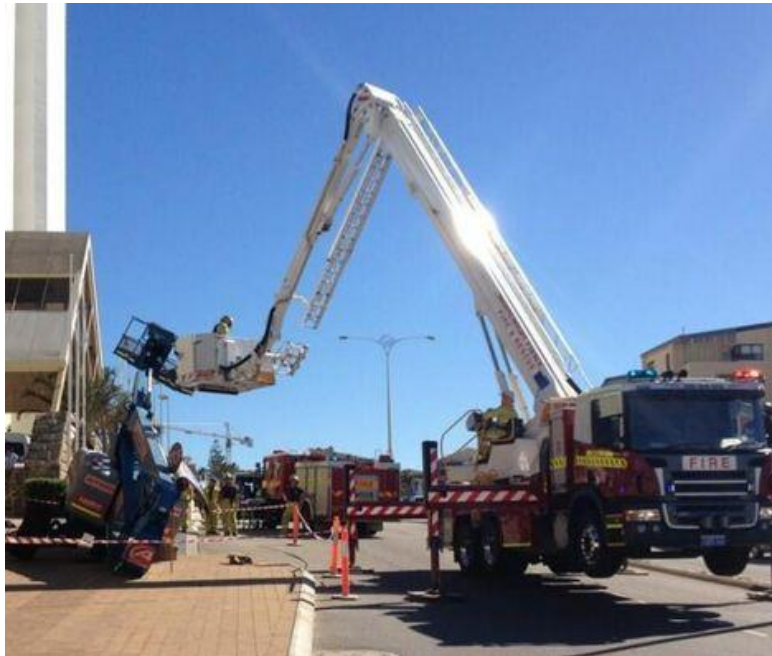
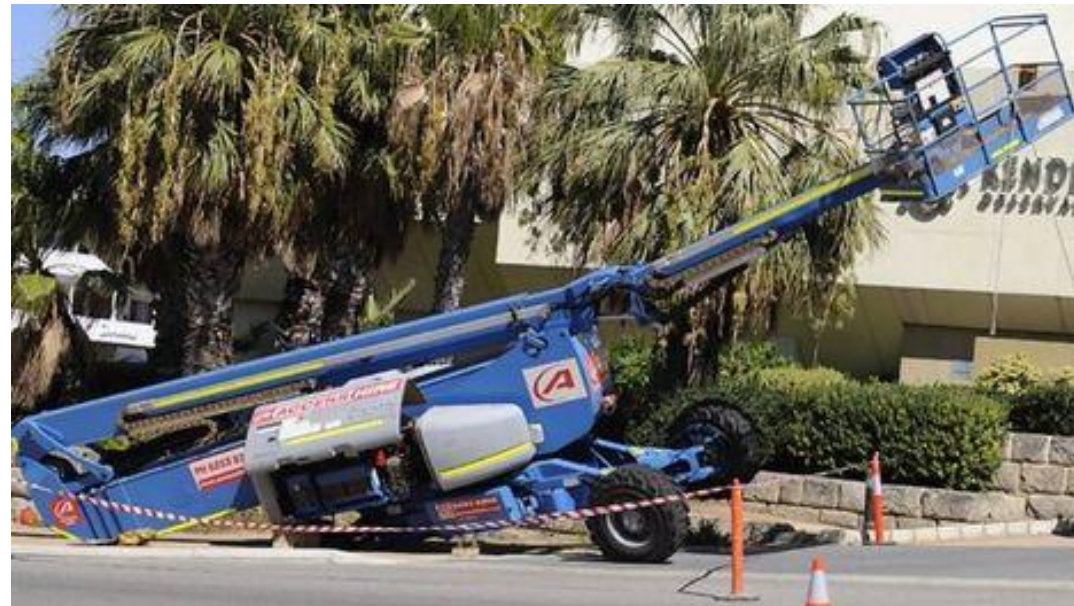
# Unsupported surface, Electric culvert cover collapsed, operator rescued. Australia.
