BMA Peak Downs Mine

Released: 23 February 2010

Broken Bolts in EWP Basket Rotator Assembly

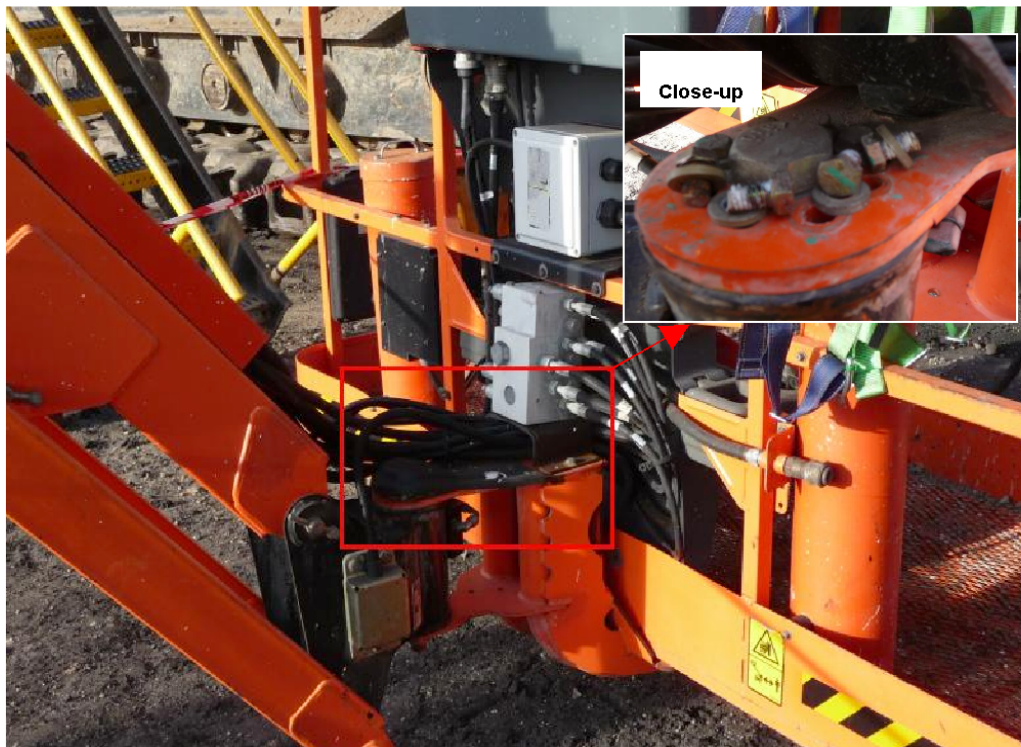
On the 23rd January 2010 at approx. 17:30hrs at the Peak Downs mine site, a tradesperson was conducting an informal inspection of the swivel section of a hired Elevated Work Platform (EWP) (Model JLG 860 SJ), when it was identified that four 3/8" bolts had sheared off from the basket slew mechanism. The remaining four bolts were identified as being loose. The EWP had been in use for approximately 1-2 hours prior to the identification of this hazard. Bolts showed evidence of having failed before EWP had started operation onsite.

The investigation identified that although these bolts have failed as per design, which is to absorb impact or overload of the man-basket, the ability of an operator to conduct a prestart inspection which identifies their failure is greatly inhibited by the plastic cover which sits over the top and contains the bolts once they have sheared. The following learning's have been taken from the review of this hazard:

- When reviewing equipment for site compliance ensure visual inspection points required for prestart checklists are visually inspectable without the removal of covers to detect non-compliances
- Maintain Vigilance with all machinery inspections
- Communication of learning's from previous incidents can prevent re-occurrence
