### ENGINE COVERS FALLING OFF BOOM LIFTS IN TRANSIT

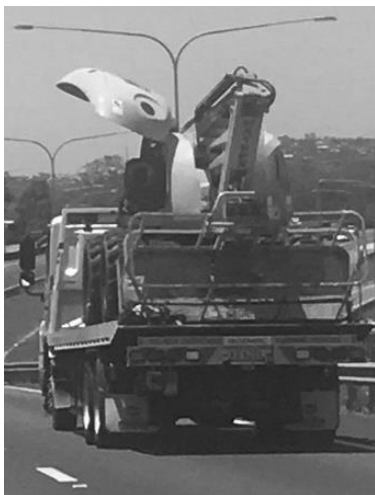
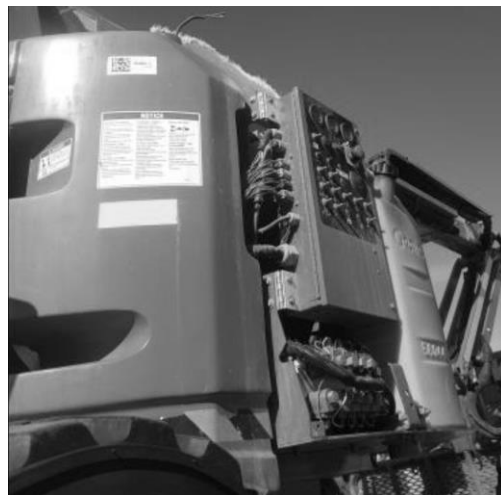
The EWPA has been made aware of a number of incidents of boom-lifts that have had their bonnets/engine covers come loose and detach from the machine while being transported. In some cases, these loose bonnets/engine covers have struck other vehicles.

- Boom-lifts exposed to air turbulence whilst being transported.
- Bonnet/engine covers not latched closed before leaving a site or a branch.
- Inadequate latching mechanisms and/or fatigued original latching devices.
- No mechanism to provide secondary locking e.g. padlock or lynch pin.

1. Circulate this alert to ensure staff are made aware of this issue. Discuss this alert in pre-start and toolbox meetings. Post the alert on noticeboards and email to any stakeholders that should be aware of this issue.
2. All boom-lifts are to have some form of secondary latching mechanism on their bonnets/engine covers that can be fastened using a padlock or lynch style pin BEFORE being transported.
3. If a boom-lift is unable to be fitted with a secondary latching mechanism prior to the next transport movement, the bonnet/engine cover must be appropriately strapped down to ensure the bonnet/engine cover remains secured while in transit.

**IMPORTANT** – *If the bonnet/engine cover cannot be appropriately strapped down, the machine is not to be transported!*

4. Acquired (second-hand) boom-lifts should be inspected to identify if secondary latching mechanisms are present. Where secondary latching mechanisms are not present, covers should be strapped down until a secondary latching mechanism can be retro-fitted.
5. Inspection of the latching devices should be included in periodic maintenance schedules and adjusted/rectified as needed.
6. Share this alert with transport contract partners to ensure they are aware this issue and recommended actions.
