SAFETY ALERT #413

Dated: Sunday, 21st FEBRUARY 2010

Title: MAN LIFT FATALITIES

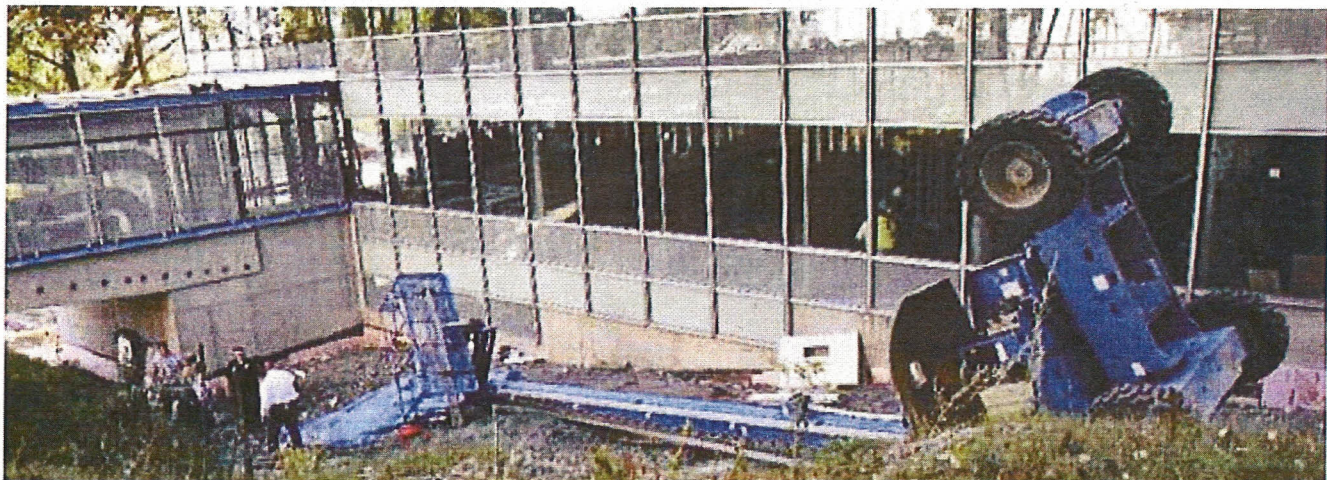
Lesson Learned Summary: A double fatality occurred when a man lift toppled over at a construction site. The two men were operating a Genie S85 telescopic boom on uneven ground and had incorrectly positioned the Lift's counter weight on the downhill side of the slope.

- **The work area where the boom was operating was not level:** Lifts / booms should only operate on a suitable, firm, level surface.
- **Counter weight and extension boom positioned improperly:** The contractors began to reposition the boom uphill while standing on the platform with the arm extended, on an uneven slope. The counter weight was located on the downhill side, shifting the centre of gravity to the downhill side, causing it to flip backwards.

- **Training competence:** Evidence shows failure to operate lift within specific operational parameters.
- **Failure of tilt sensor and audible alarm:** The tilt sensor is specifically designed to alert the operator(s) in the lift basket, via audible alarm, when an unsafe condition (non-level working orientation) is being approached. The resulting investigation discovered that the Tilt Alarm been disconnected, although when and by whom was never fully understood.

- Only operate on suitable, firm and level surfaces.
- Never operate drive system while boom in extended position.
- Ensure Pre-Task planning accounts for all operating conditions and parameters related to the specific equipment being used:
 - Includes review of equipment operations manual.
 - Provides for pre-operation inspections, including safety systems integrity (e.g. tilt alarm is in proper working condition).
 - Incorporates review of specific site and area conditions.
 - Ensures next, immediate user of borrowed equipment is responsible for its readiness for use.
- Consider physical barriers to prevent boom lift movement in areas where unlevelled or unstable conditions are adjacent to planned work area.
- Training should be specific to the type and model of equipment being utilized.
- Robust maintenance and inventory program to ensure equipment is in appropriate working condition.

Vandalism of the tilt alarms is common and should be outlawed and monitored by users / supervisors and site management
