# SAFETY ALERT

## HAULOTTE H16TPX BOOM TYPE EWP

**SERVICE BULLETIN #101**

**Subject:** Jib linkage Inspection

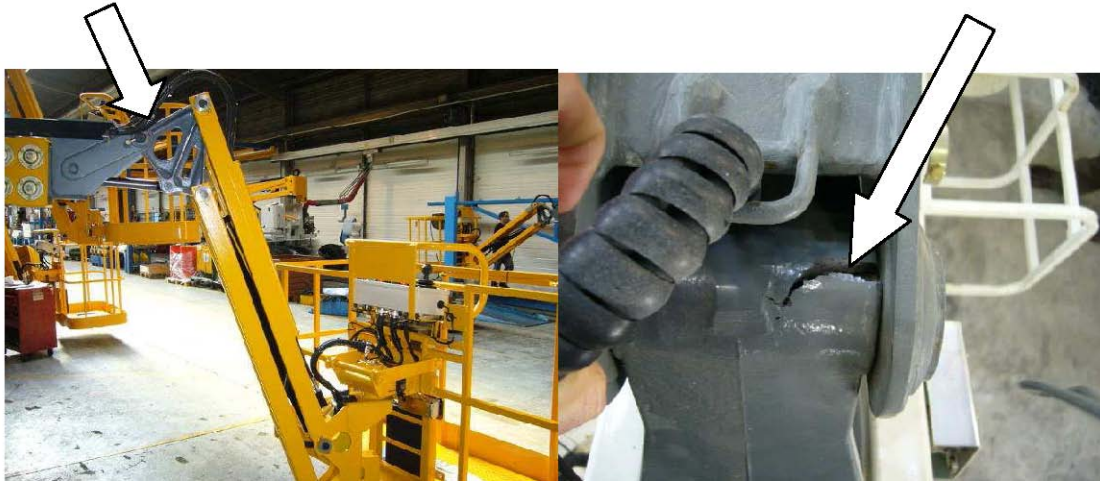
With the utmost concern to ensure quality and safety of our products, we would like to draw your attention to a progressive component failure which was either missed or ignored during the routine inspection process set out in the manual supplied with the product.

As with products of this type, it is possible to subject the jib/link to high shock loads via contact with fixed objects or the like. In the event that the operator/owner has a suspicion that such a contact has taken place, the whole mechanism from the link back to the basket must be carefully inspected with particular attention being paid to the link which is the subject of this bulletin, including the metal casting linkage that could crack in the area as shown in the pictures below. As a matter of normal precaution, it is recommended that the link should be checked during the routine inspection.

**In the event that the jib linkage is found to be damaged, the machine should be put out of service and the link replaced without delay, before using the machine again.**

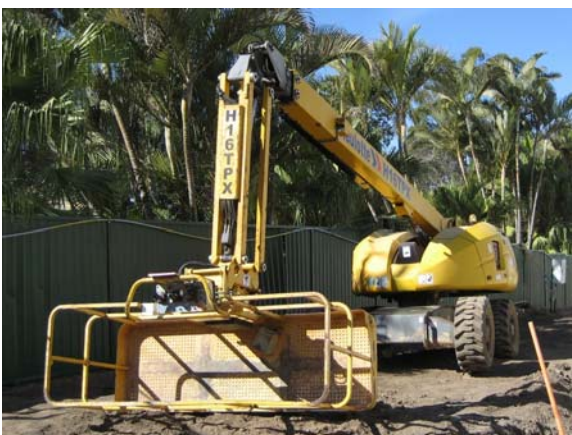
The linkage between the fly jib and boom catastrophically failed and allowed the platform to drop so that it hung vertically (refer Photograph 1). Photograph 2 shows a close up view of the failed linkage. The linkage on this particular model is manufactured from cast steel.

**Photograph 1** – General view of EWP with platform hanging vertically

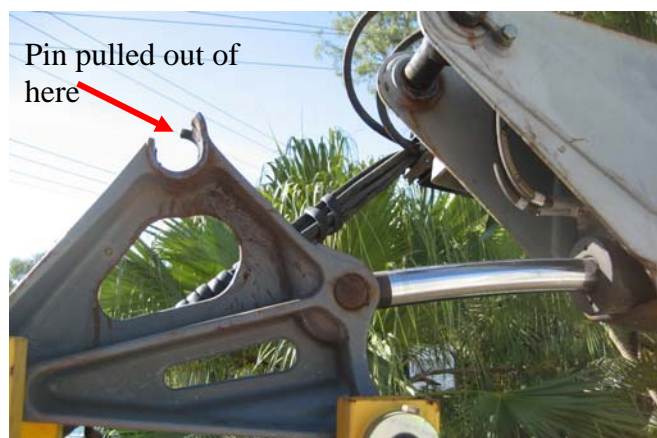
**Photograph 2** – Close up of failed linkage

As a matter of urgency, all Haulotte boom type EWPs with a linkage similar to that shown in Photograph 2 are to be inspected by a competent person.

If cracks, excessive wear or other damage are found, then the EWP is to be removed from service. Haulotte Australia Pty Ltd is currently investigating the issue. Owners should seek guidance from the manufacturer on inspection criteria and remedial measures to be taken. Haulotte Australia can be contacted on 1300 207 683.
