To: All Service Managers and Owners
From: Doug Floyd
Date: 15th June, 2009
Re: Parker Drive Motors. PNo BG0335CS080AAMP and TG0335US080AAAF Investigation

Due to the recent reported incidents of wheel motor shaft failures on front and rear Parker Hydraulic Drive Motor used in Snorkel SR2770. Snorkel recommends that all owners of SR2770 built between 2000 and 2006, and with serial numbers between **NZ000401** and **NZ060908**, visually inspect their machines for possible cracking in the key way area of the drive motor shaft.

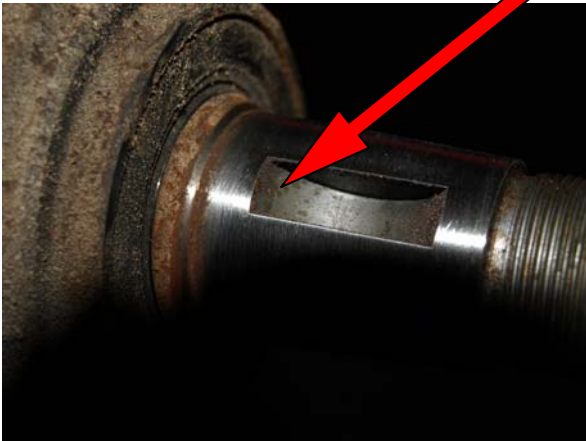
Use die penetrant to check for cracks in the key way area.

If cracks are detected notify the nearest Snorkel Service department or agent. Please supply Model and Serial Number of both machine and wheel motor, and remove machine from service.

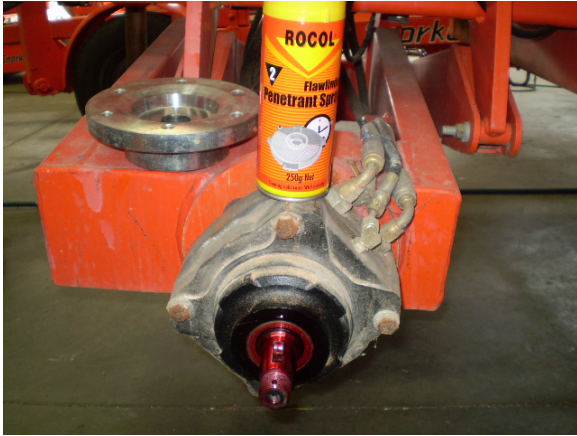
Use die Penetrate as shown below.

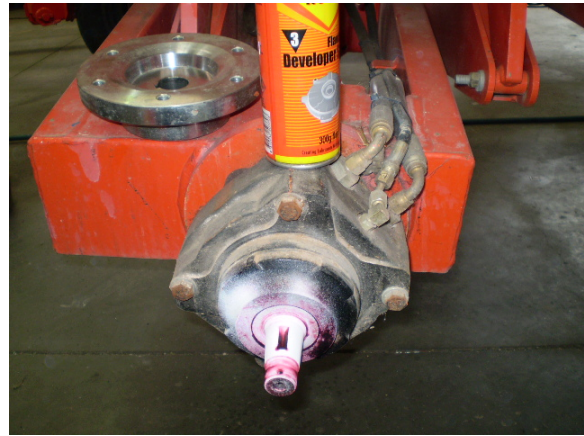
Use developer to show up cracks in axle.
