# SAFETY ALERT

## HAULOTTE H16TPX BOOM TYPE EWP

**SERVICE BULLETIN #101**

**Subject:** Jib linkage Inspection

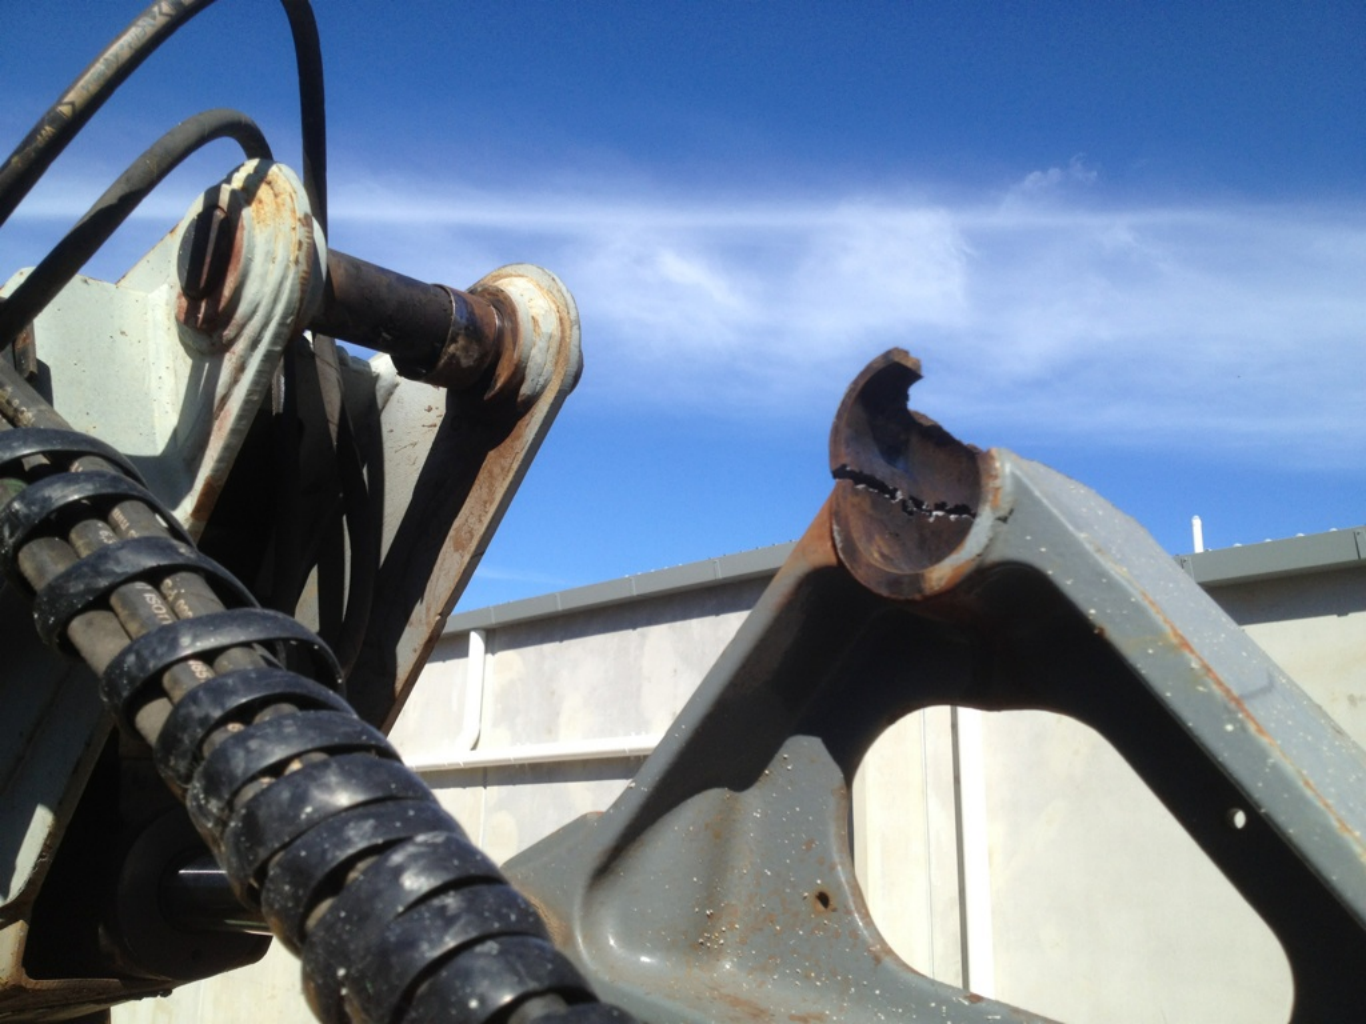
The linkage between the fly jib and boom catastrophically failed and allowed the platform to drop so that it hung vertically (refer Photograph 1). Photograph 2 shows a close up view of the failed linkage. The linkage on this particular model is manufactured from cast steel.

**Photograph 2** – Close up of failed linkage

As a matter of urgency, all Haulotte boom type EWPs with a linkage similar to that shown in Photograph 2 are to be inspected by a competent person.

If cracks, excessive wear or other damage are found, then the EWP is to be removed from service. Haulotte Australia Pty Ltd is currently investigating the issue. Owners should seek guidance from the manufacturer on inspection criteria and remedial measures to be taken. Haulotte Australia can be contacted on 1300 207 683.
