Elevating Work Platform Transporting Incidents

Elevating Work Platform Transport Incidents

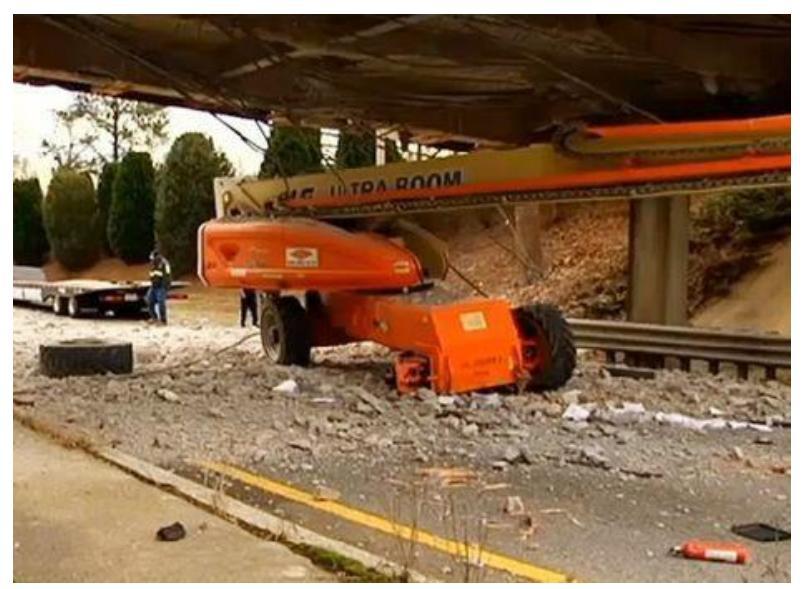
A truck transporting a large boom lift struck a bridge over the 1-585 Interstate in South Carolina last week moving one of the bridge decks over a metre and a half.

The damage on the boom lift is surprising light given the impact

The incident occurred last Monday near Spartanburg when a JLG Ultra Boom, owned by Ahern Rentals and transported by a private contractor, passed underneath the bridge at speed, ripping the lift off the trailer and moving the deck.

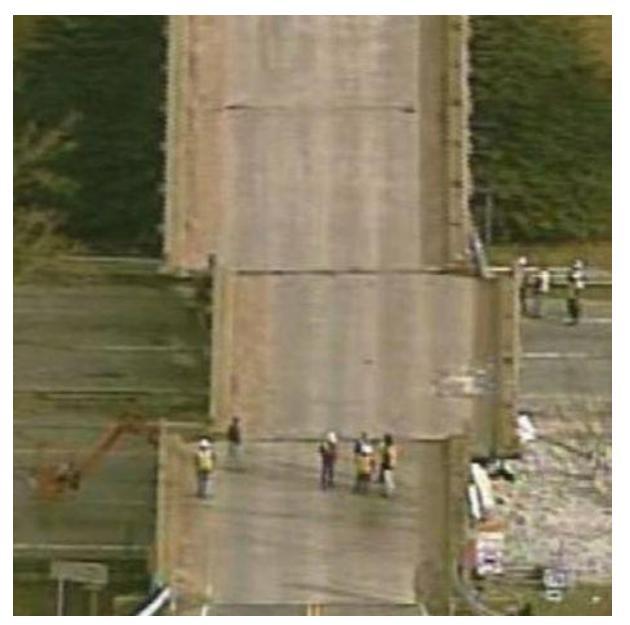
The bridge deck was moved over 1.5 metres

The bridge was built in 1957 and had a clearance of 13ft 10" or 4.2 metres. Thankfully no one was injured in the incident.

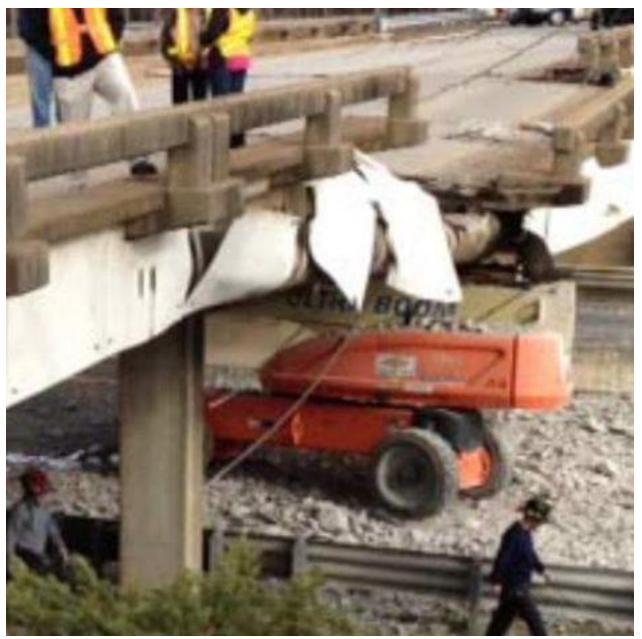
The bridge was damaged beyond repair

The bridge section has now been removed and the Interstate reopened. Police said that the driver of the tractor-trailer has been charged with discharging his load on the highway.

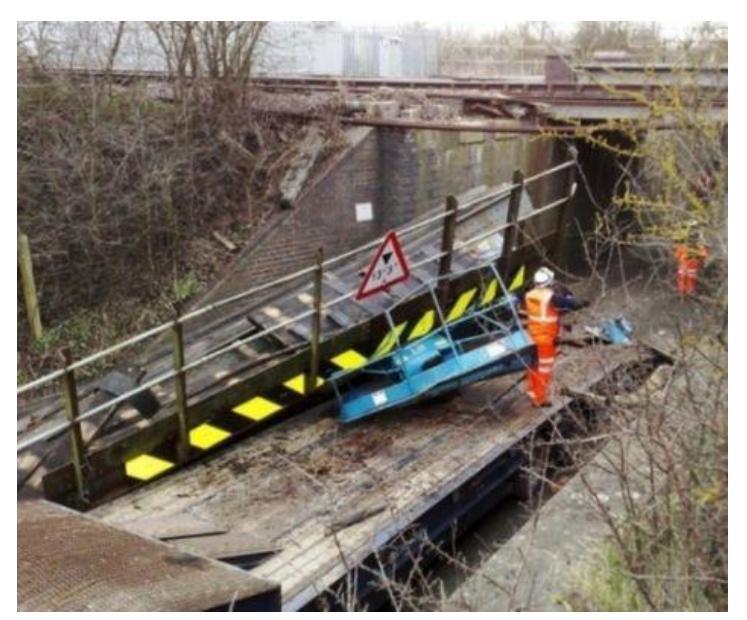
The truck caught part of the bridge as it came out

This looks like a case of a hanging obstacle that the driver missed, the Genie boom has an 9ft overall height, so in order to catch a 13.3ft (4.0m) bridge the trailer bed had to be 4ft 3 inches high (1.3 metres), which it clearly is not. The fact that it passed beneath the first bridge and then the first half of the second bridge would also seem to confirm this.

However this incident does raise the importance of knowing the overall height of the load and comparing it with the bridge height before passing underneath.

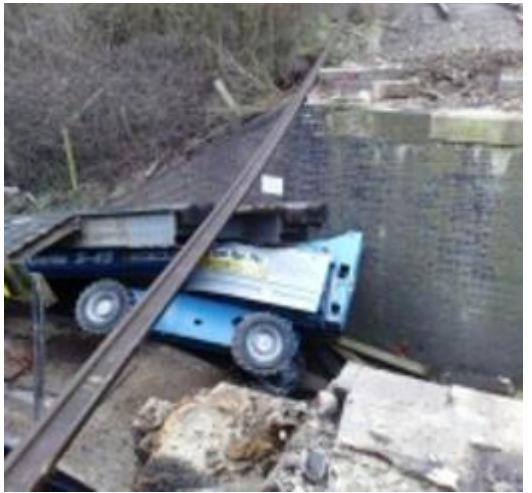
The boom lift, a Genie S-65 owned by local rental company Easi-Uplifts was on the back of a low-loader and stowed correctly. It apparently went under the first bridge which has a 13ft 3inch clearance-height with no problem, but caught the second bridge, which has the same clearance height as it came out from under it.

The boom appears to have been stowed correctly

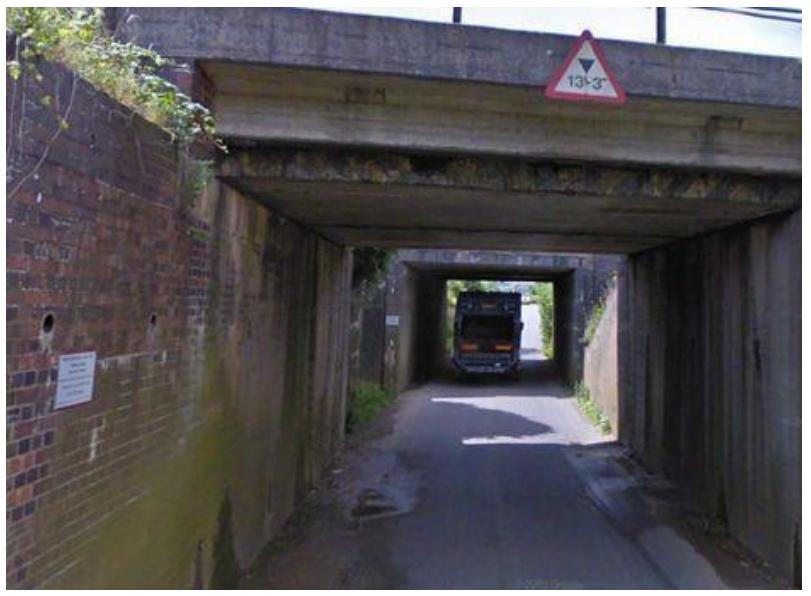
Locally there were suggestions that the bridge which came down had been subjected to earlier damage that might have reduced the clearance height.

The Fenny Compton rail bridges prior to the accident

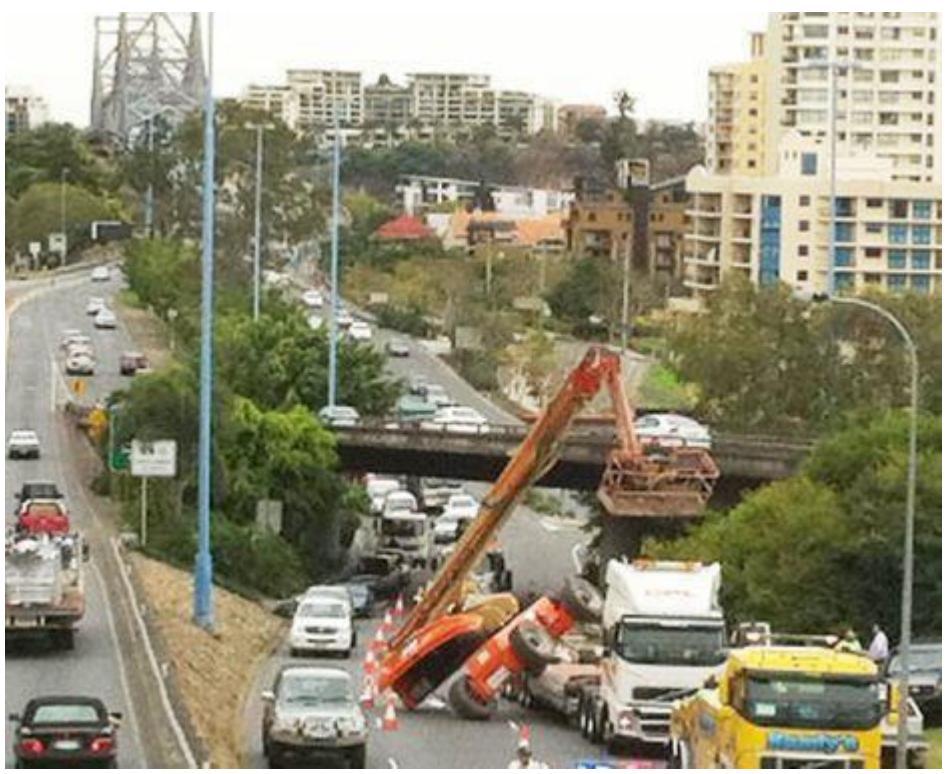
The boom lift was just high enough to catch the bridge

The lift, a JLG Ultra boom, was being transported with the boom slightly elevated in the jib tuck-under position which reduces the overall length of the machine but can increase the overall height just enough to catch the overpass.

Unlike many smaller boom lifts where the jib tuck-under position causes an increase in overall height, the JLG ultra booms will stow in this position without increasing their 3.05 metre overall height.

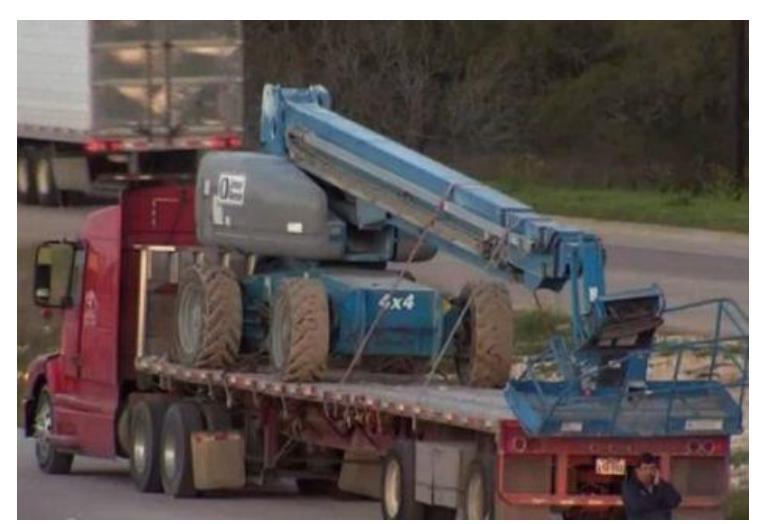
According to police the truck, carrying a Genie boom owned by United Rentals on a flatbed trailer, struck the beam of the bridge, which is currently under construction on Interstate 35 in Salado, Texas to the north of Austin.

The boom lift was only lightly damaged but the incident it cased was major

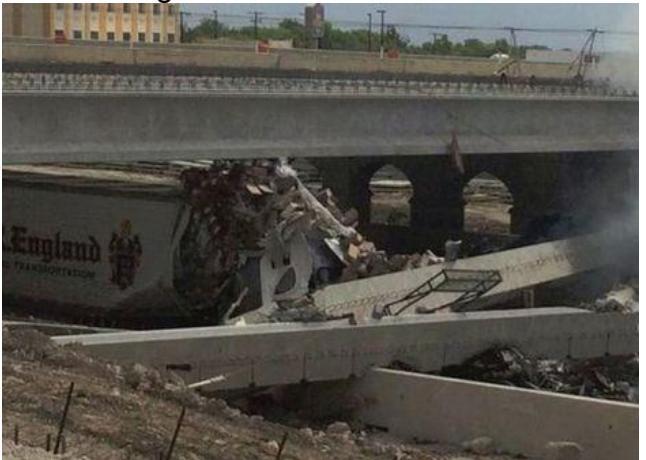
Debris and rebar from the beam was brought down, causing the beam to be hung up on a larger high sided truck which pulled the beam – down onto the front end of its cab and the pick-up truck.

The next truck caught up in the damaged beam and pulled it down

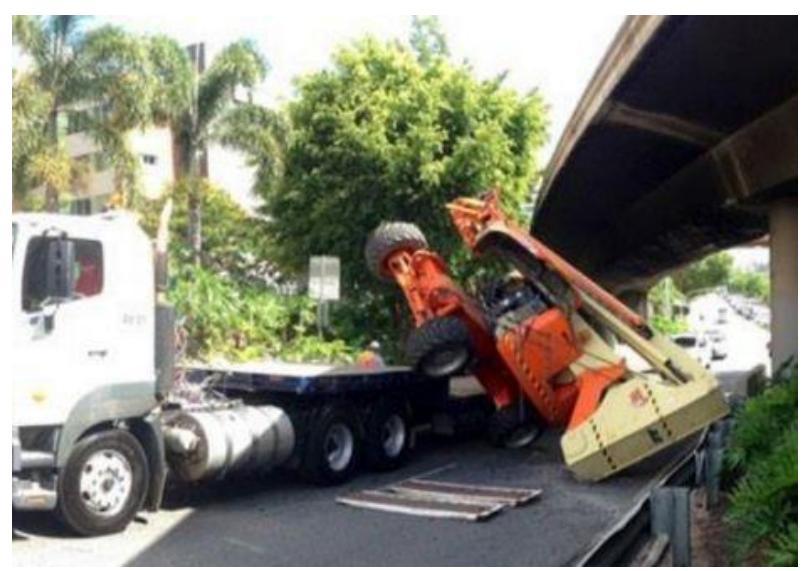
The boom struck the overpass as it went under

Photos indicate that the riser on the JLG – possibly an 800 series articulating boom – was not full stowed, raising its height by a critical 200 to 300mm or so. The incident occurred as rush hour traffic was getting underway, causing considerable delays.

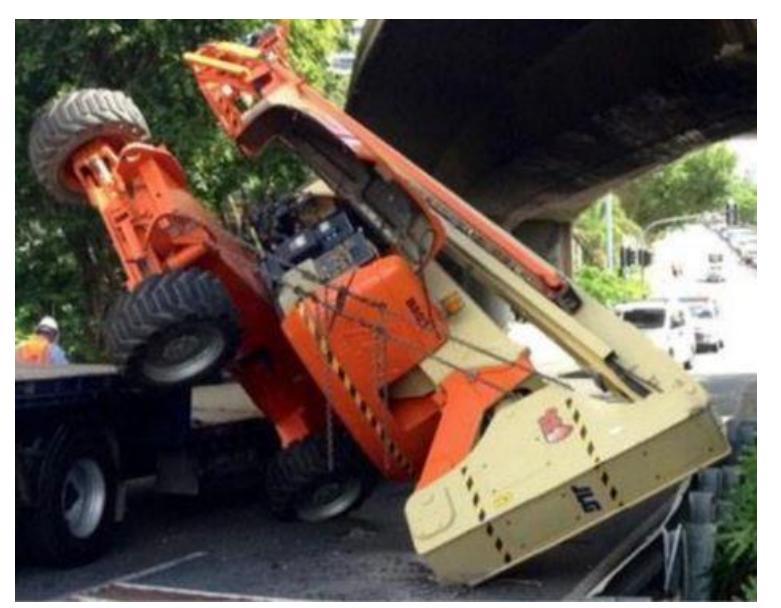
It looks as though the riser was not fully lowered

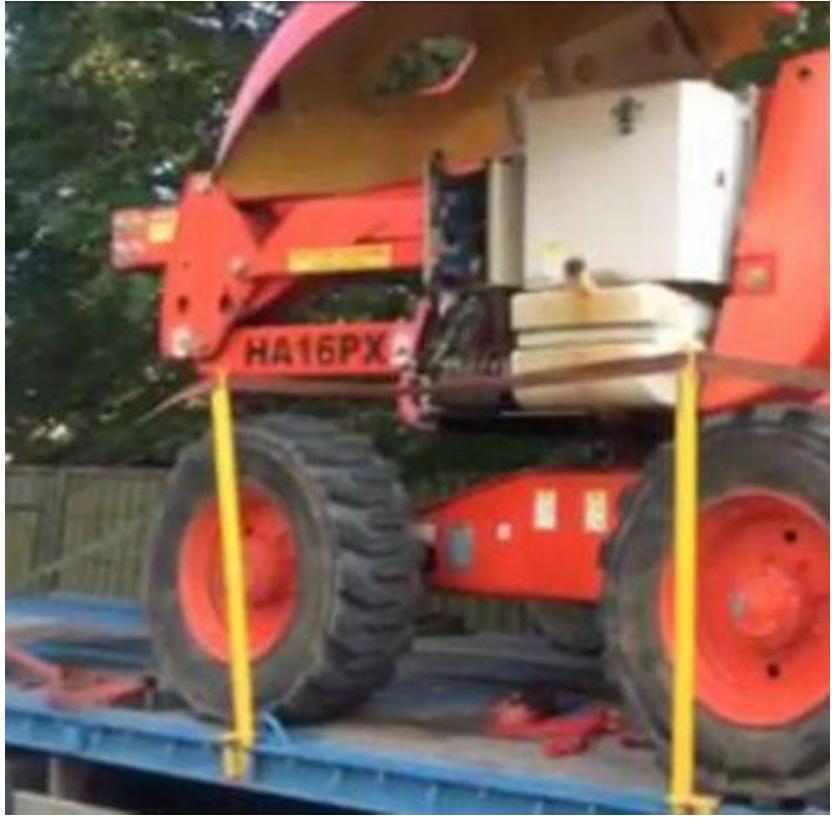
Photos we have been sent seem to show that the boom, jib and platform were properly stowed which would mean that the jib knuckle which protrudes slightly caught on the underside of the bridge and jammed sufficiently to pull the fly section out.

The machine remained firmly on board

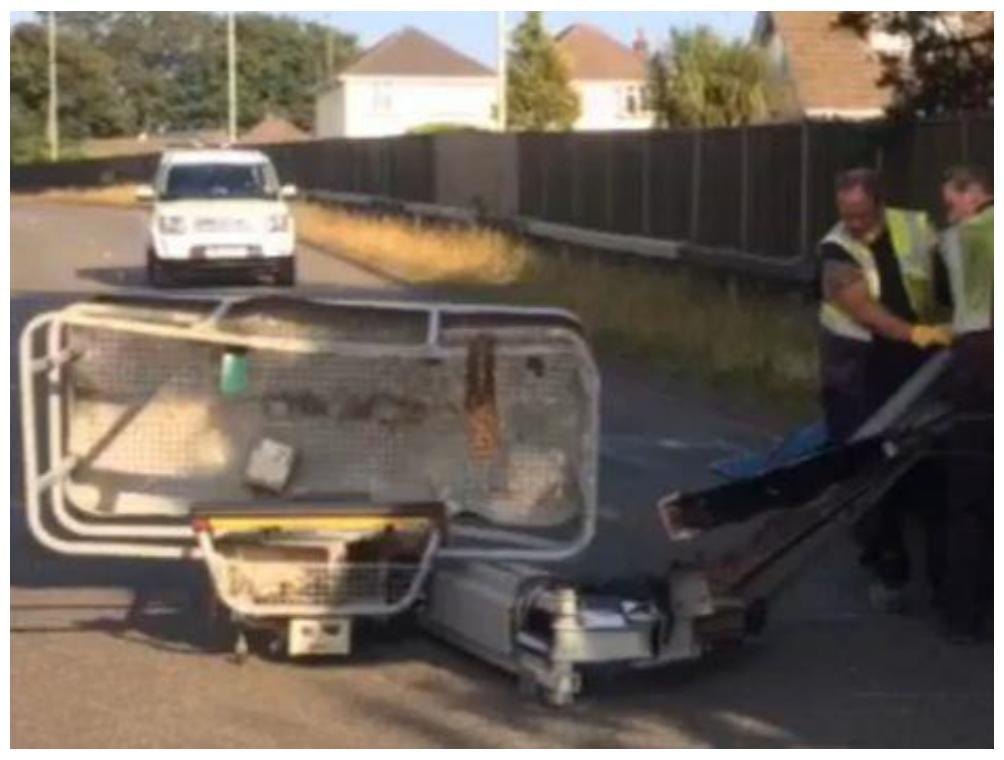
We understand that the boom section, jib and basket after striking the road remained attached to the machine via its hydraulic hoses and cables. The truck pulled up and help was called to load the section back onto the truck. Meanwhile the road was closed while the bridge was checked and the road surface patched. Thankfully no one was injured.

The boom section, jib and platform are recovered under the eye of a police car

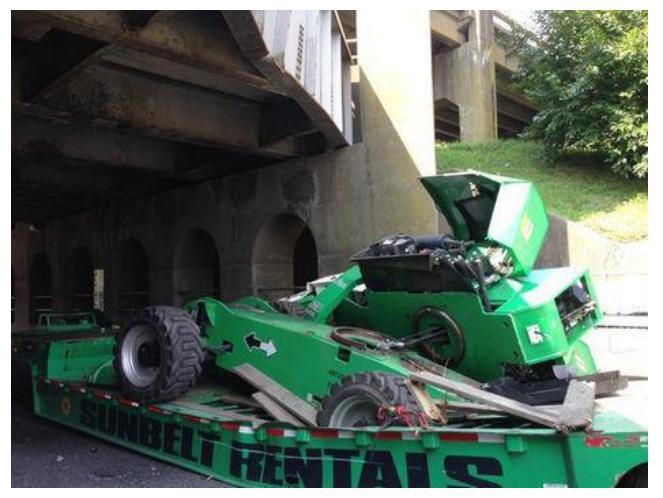
The unit, a relatively new JLG, is owned by Sunbelt Rentals and is the delivery rig. The driver suffered from minor injuries in the incident. The bridge was damaged and the road was closed for some time while a large oil spill was cleaned up and the truck removed.

The superstructure is ripped off

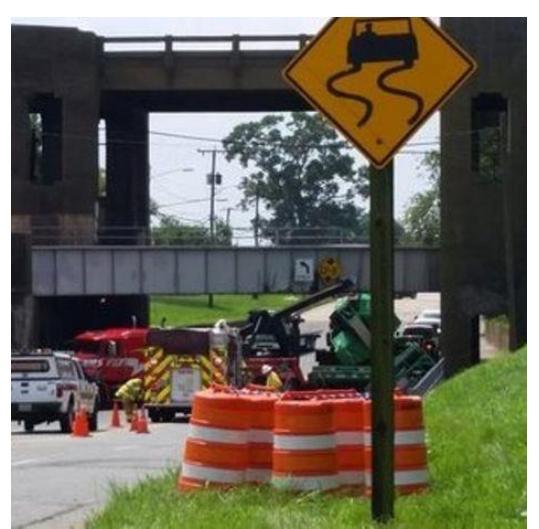
The bridge is supposedly over four metres high (13'8"), which should have provided sufficient headroom as the stowed height of the machine is around three metres.

The lower bridge is supposed to have a clearance of almost 4.2 metres

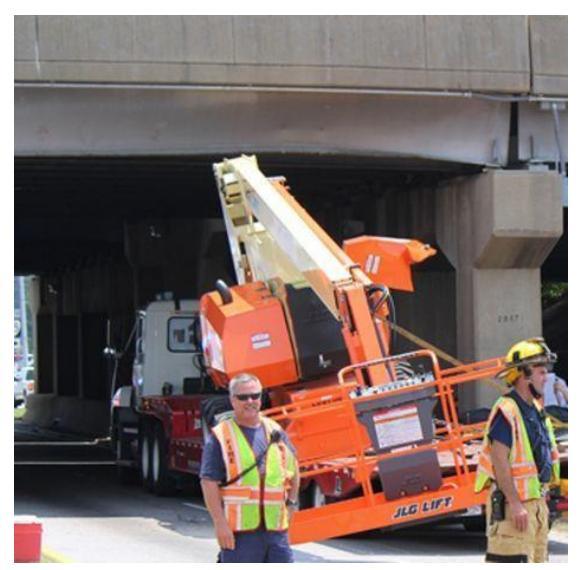
The scene after the incident as emergency services look to recover/remove the truck

The bridge/overpass sustained some damage to the large I-beam it smashed into but the roads were reopened later in the day. No one was hurt in the incident. The riser knuckle on the boom lift, a JLG 800AJ, was simply too high to pass under the bridge, possibly due to not being fully stowed? The impact appears to have broken at least one of the wheel axles.

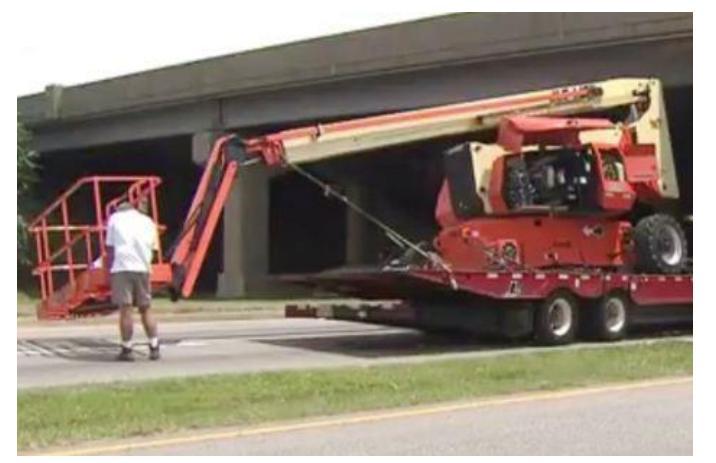
At least one of the wheels broke off

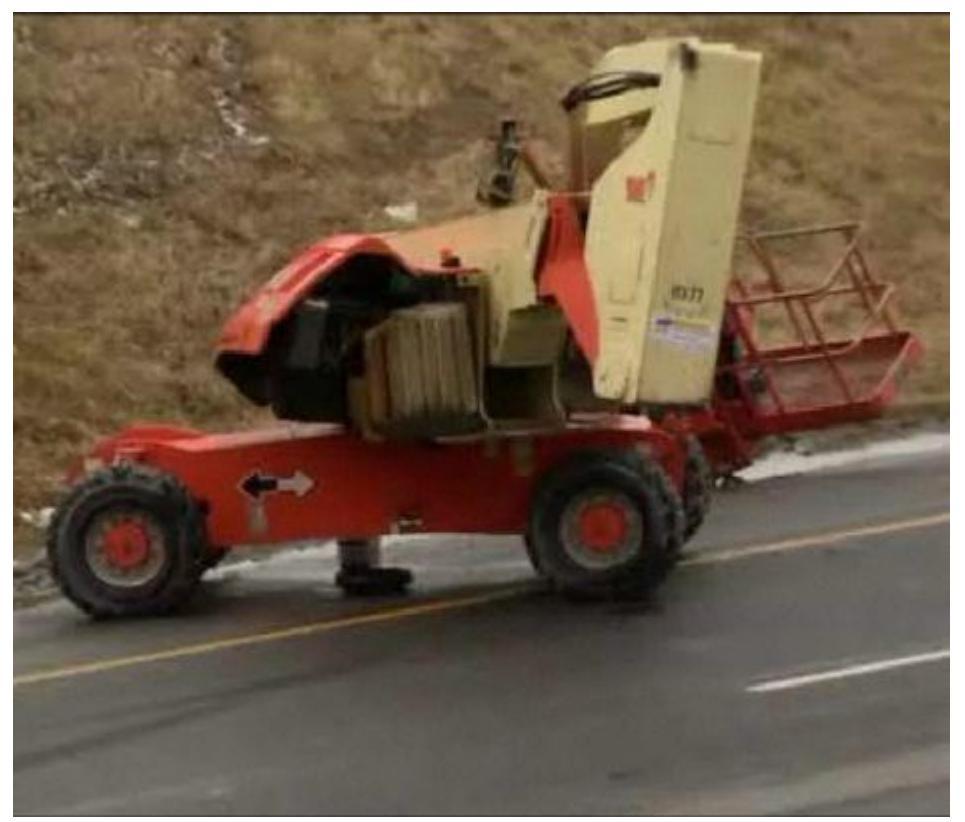
The lift clearly suffered a serious impact

The impact was such that the roads remained closed well into the evening as engineers inspected the bridge for damage.

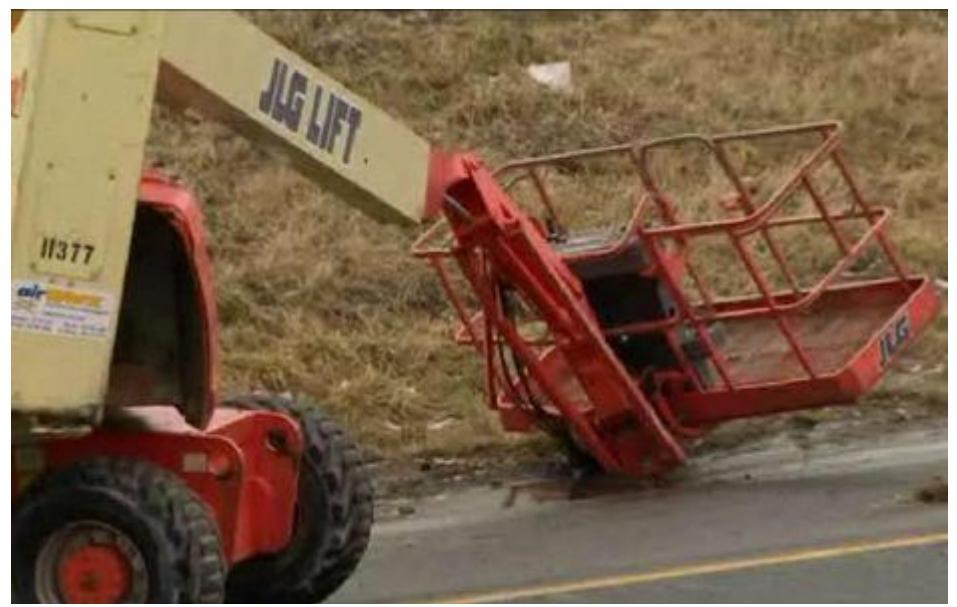
Repairs will be costly

The lift looks like a JLG 600AJ and is owned by local company Air Worx, how it was high enough to strike the bridge is uncertain.

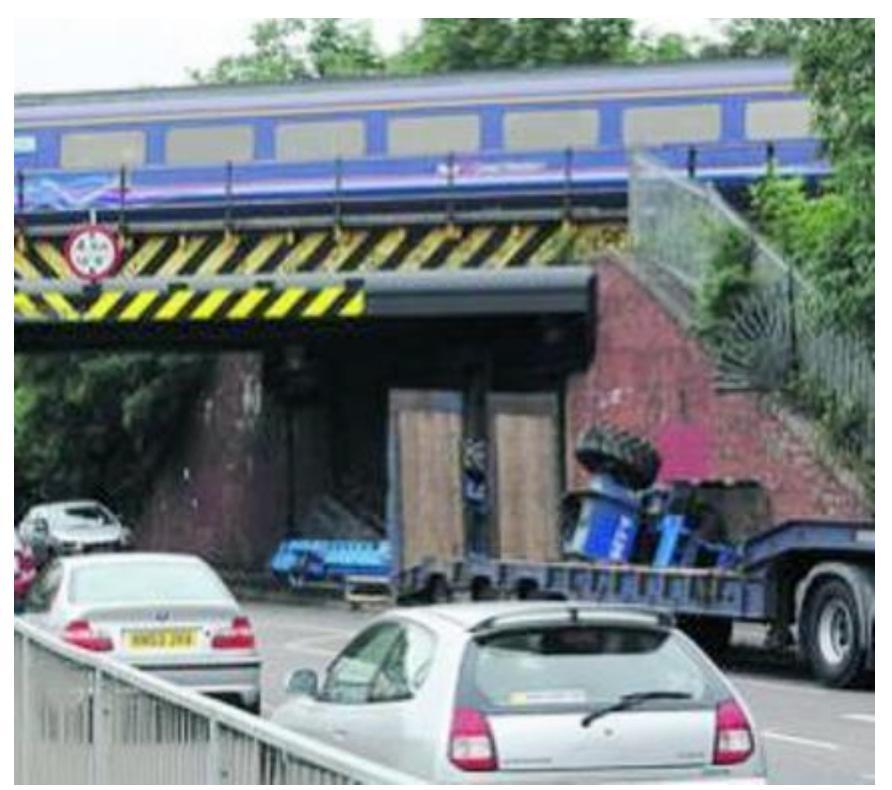
No one was hurt in the incident and damage appeared to be limited to the boom lift. There was however considerable disruption to traffic while the unit was recovered from the scene.

The scene yesterday

No further details are available but we do know that the bridge, which has a history of being bashed, is supposed to be 4.5 metres high.

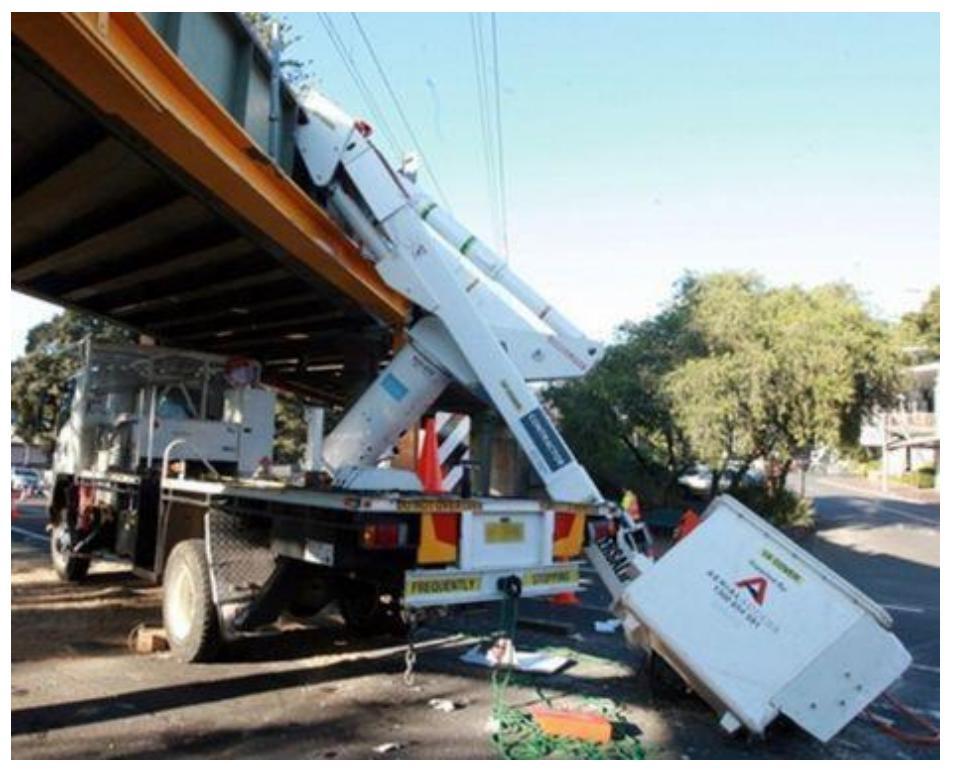
No one was hurt in the incident but the lift and the truck will need some work. The rail bridge is not believed to have been badly damaged but RailCorp sent an engineer out to check it.

The truck mounted platform's boom collided with the bridge in Kiama, New South

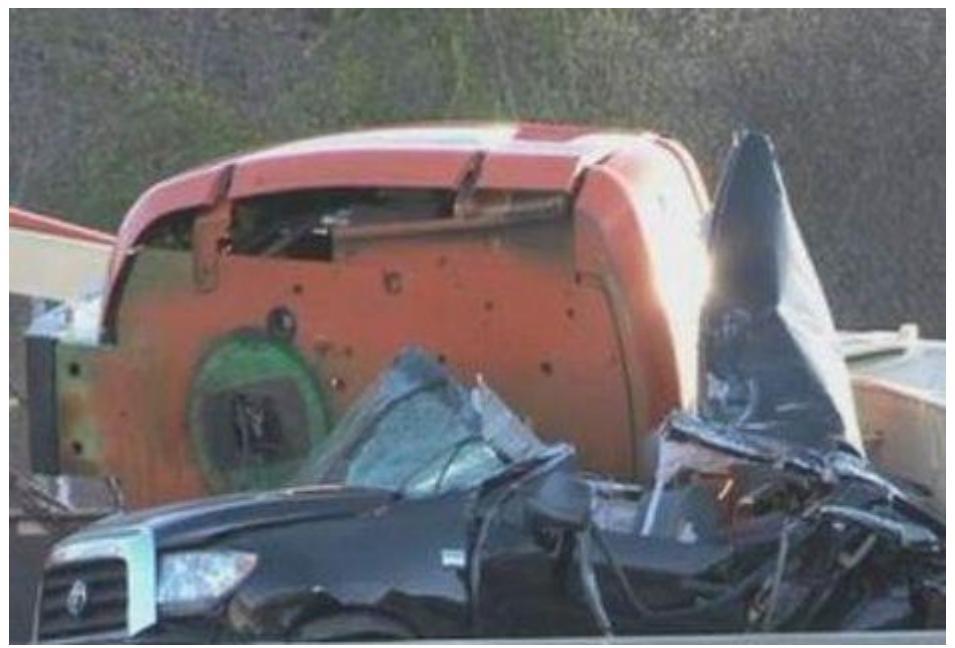
The lift was travelling on route 146 and struck the I-295 overpass when the incident occurred. The driver of the pick-up, James Reilly 52, miraculously escaped serious injury although his vehicle was completely crushed. He was taken to hospital but later released.

The superstructure crushed the vehicle, but the driver escaped uninjured

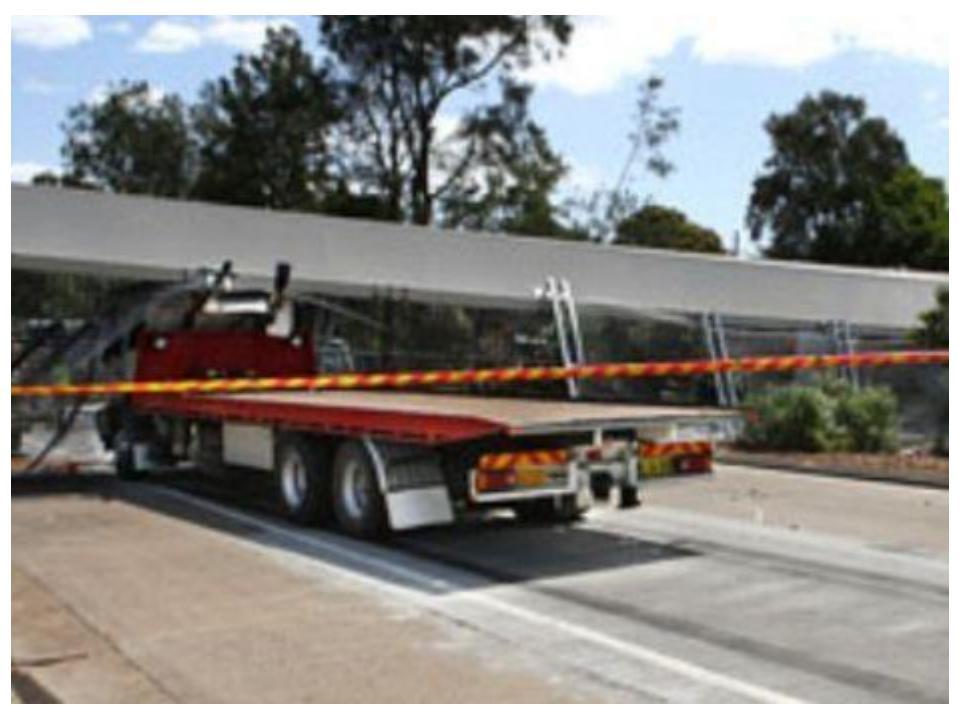
A self-propelled boom lift travelling on the back of a low loader struck and brought down a footbridge in Maitland, north of Newcastle, Australia earlier this week.

The footbridge came crashing down onto a car and a truck

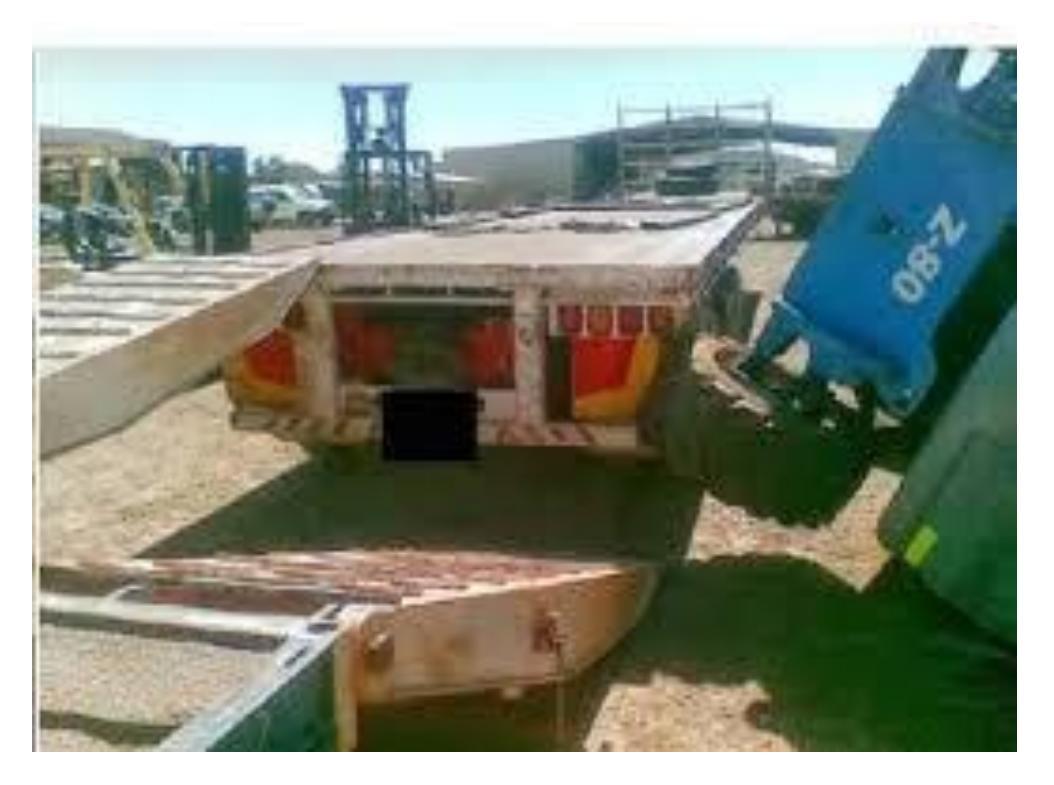
The accident happened at a transport depot yesterday morning when one of the ramps he was using to transfer the 80ft boom lift gave away. Reports say that he was around a metre from the ground when the boom tipped, throwing him out of the basket. He was taken to Nichol Bay Hospital but died as a result of his injuries.

Local police said, "They were fairly high off the ground and the ramp that was used to drive the platform across failed and caused the elevating work platform to tip. The deceased had fallen out as a result and suffered injuries from the fall."

We understand that the man was not wearing a harness.

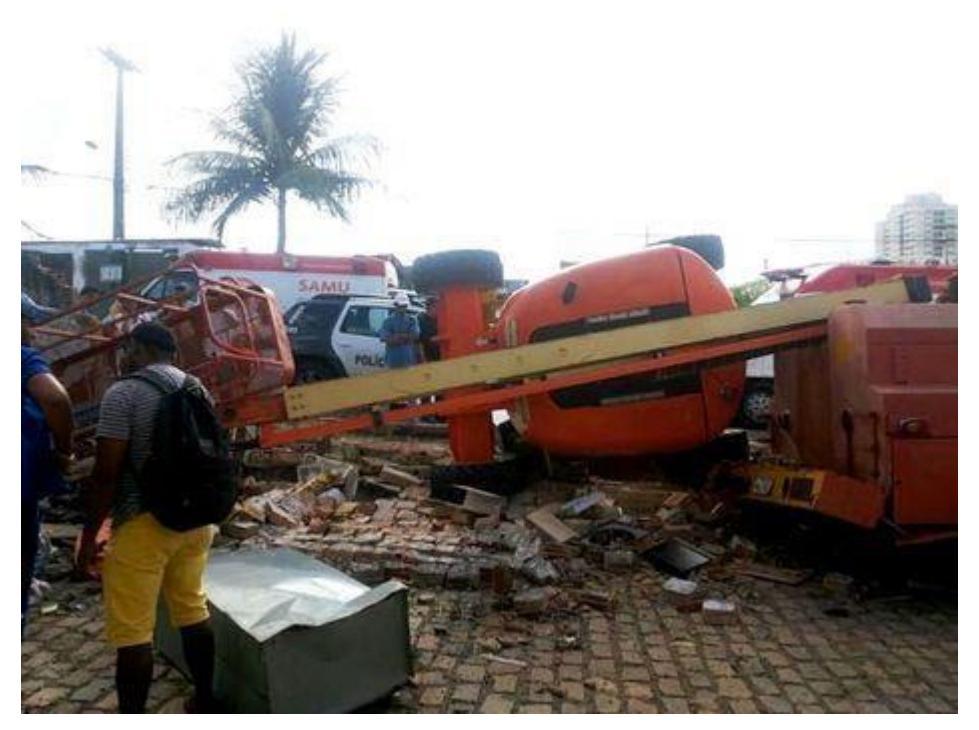
Details on the incident are limited; however it appears Joaquim Carneiro Bastos Neto, 48, was loading the JLG boom lift on to a truck at the yard of a rental company when it slipped off the side. It is not known whether Neto was struck by the falling boom lift or whether he was thrown from the basket. He was declared dead at the scene.

The overturned boom lift

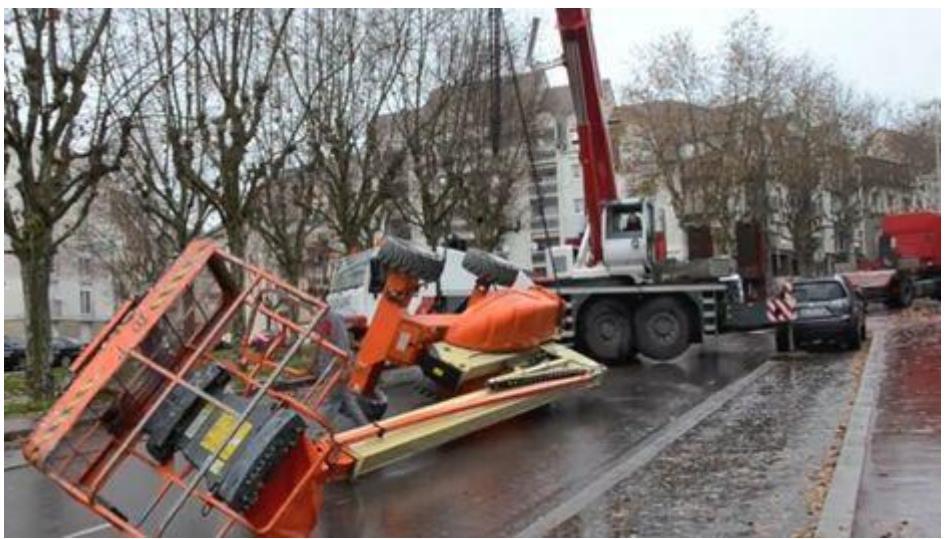
The overturned lift - note the delivery vehicle in the background

We believe that the lift, a 60ft JLG M600J owned by Medloc of Montceau Les Mines, was being unloaded from a trailer in the street when it slipped off the side and overturned, injuring the delivery driver/operator.

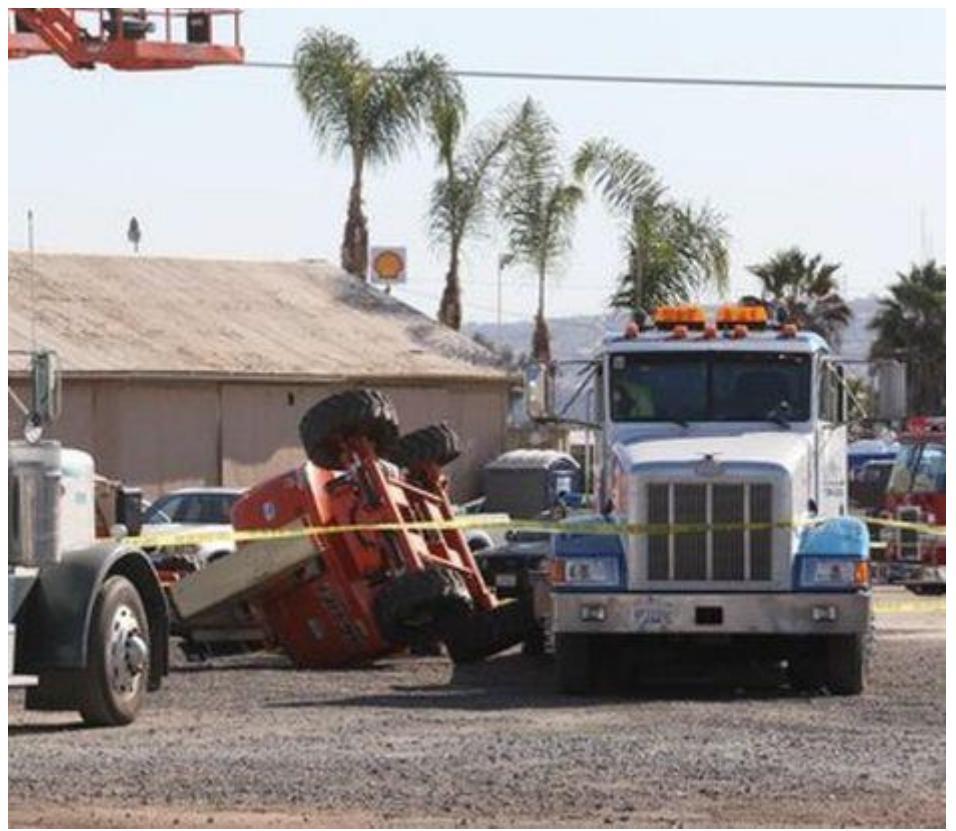
The incident occurred in the Palm City area of the city. The man, who would have been 59 on Saturday, landed on his head when the machine went over. We do not know if he was thrown from the platform or managed to hit his head from within the basket.

The boom slipped off the side of the low loader

Unloading aerial lifts – and other equipment from delivery trucks can be one of the highest risk manoeuvres if not carried out with due care. Too many drivers still refuse to wear a harness and short lanyard when unloading in spite of the high risk of serious injury or death from being catapulted from the basket.

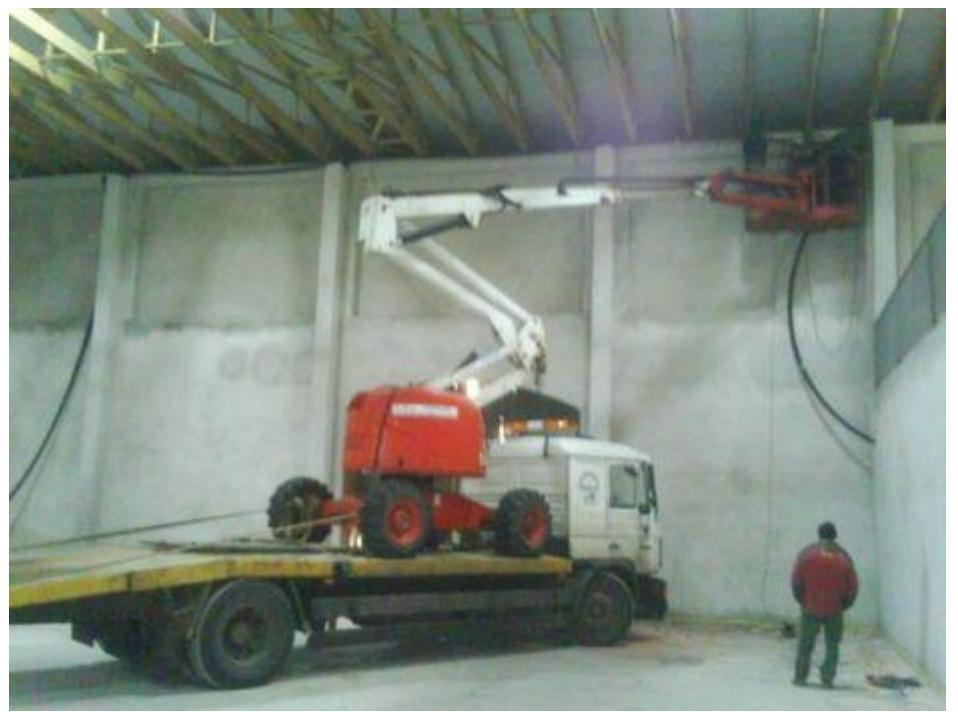
The worst thing about this one is not that it is intrinsically unsafe or that due to the trucks suspension the whole lot could go over and result in a fatality or two, the worst thing about this one is the fact was that this picture was found on the website of a company offering services that involve working at heights.

Why bother unloading?

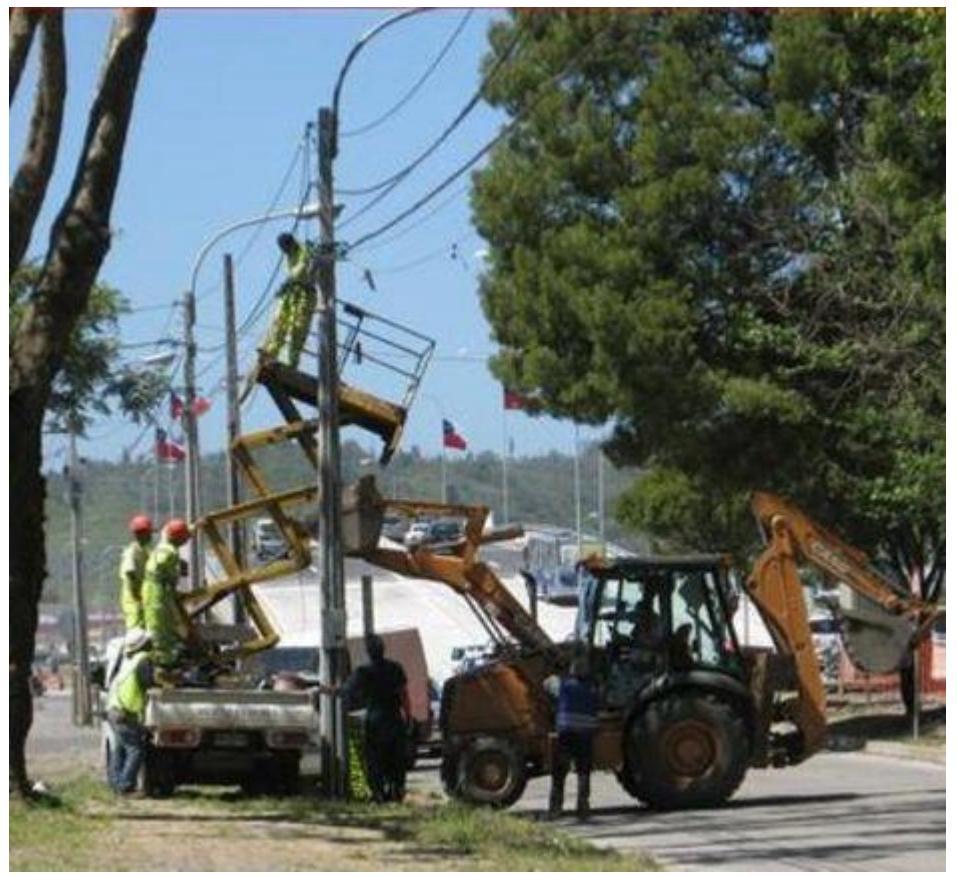
It seems that the men were working on overhead wires and, in order to reach them, used an old scissor lift on the back of a truck. However the truck is not directly underneath the point of work so for some bizarre reason that we cannot work out, the lift is extended at an angle and the team has brought in a front end loader to stop it falling over.

We are not sure what is exactly going on here, but it does not look good.

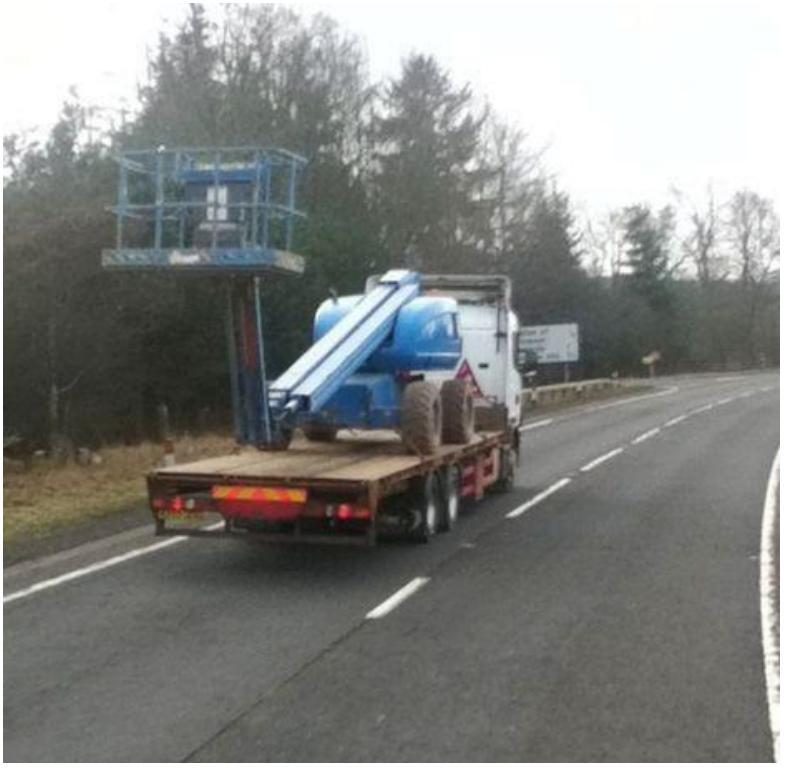
As our correspondent points out, the basket and articulated jib should have been tucked under and secured to the truck bed, as a) The superstructure is not restrained and b) The basket is the highest point on the vehicle. Possibly worst of all, in light of the above, the slew pin was not installed.

Higher than truck, nothing to restrain it slewing over the side

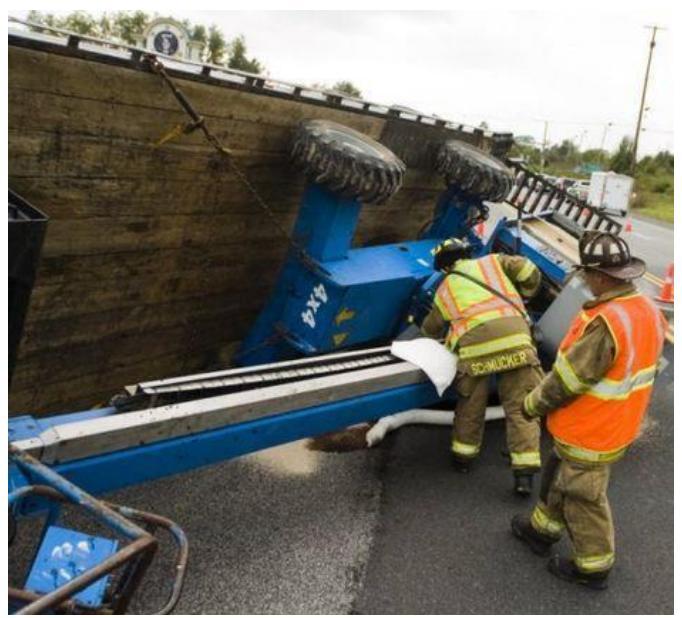
The boom, which looks to be a Genie S45 4x4, was certainly well secured and remained firmly tied down in spite of its 5.5 tonnes/12,000lbs overall weight. Fortunately no one was injured in incident although the road had to be closed while the recovery took place.

The boom, which looks to be a Genie S45 4x4 was certainly well secured

As to what caused the trailer, which was being towed by a pickup truck belonging to Danner's Bobcat Service, to overturn we cannot say. However a load of this weight seems high for the trailer. If a tyre had blown or the driver had been forced to swerve at high speed, the reaction could have easily built into a sufficient force to flip it.

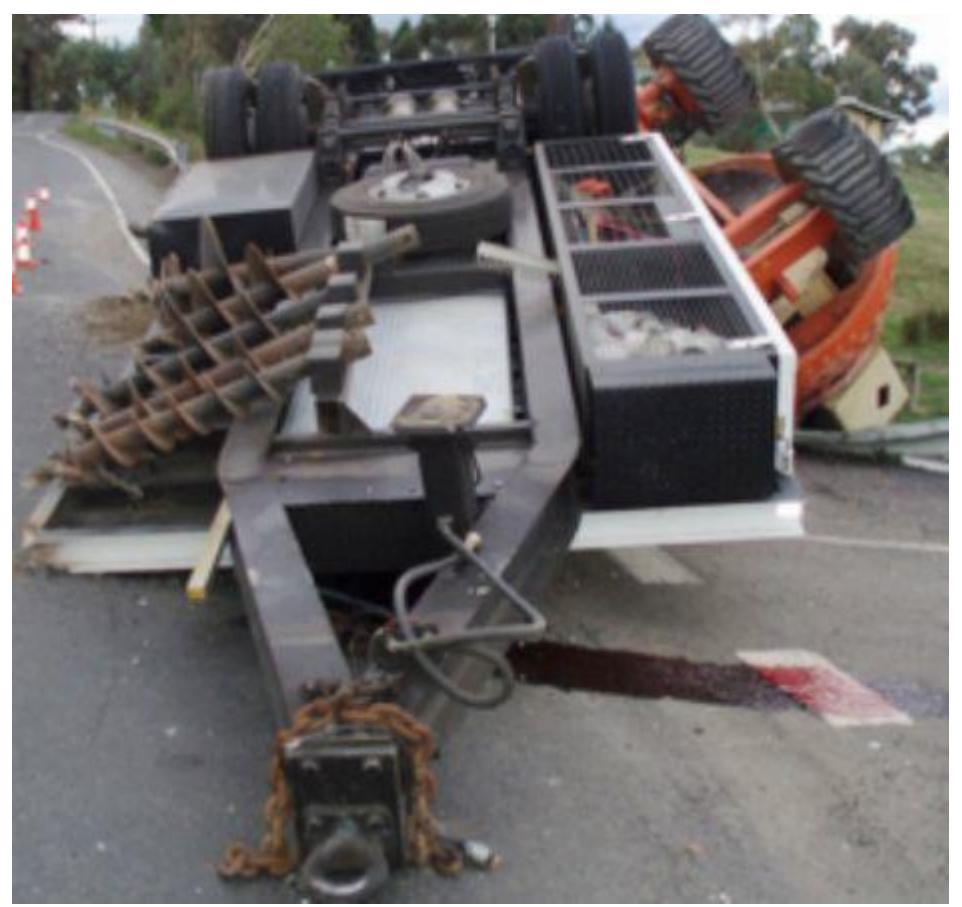
A 13 tonne trailer carrying a self-propelled boom lift overturned as the towing vehicle, reportedly a dump truck, took a corner too fast in the town of Plenty, Victoria North East of Melbourne in Australia.

The overturned trailer and boomlift

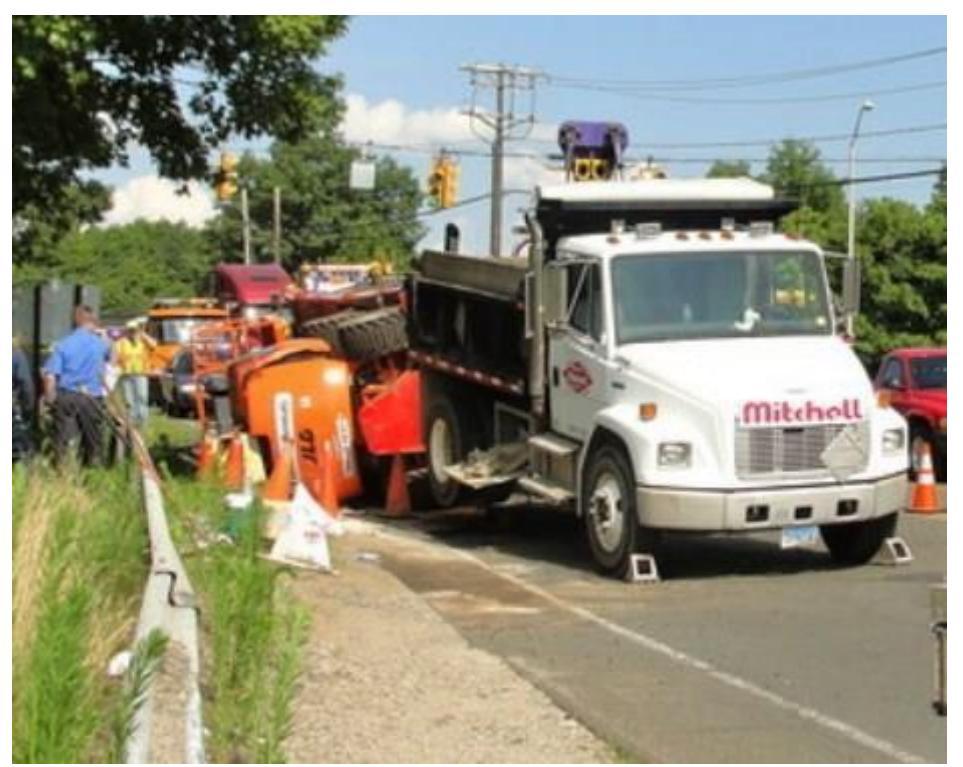
A dump truck towing a boom lift on a two axle trailer caused a traffic jam on Thursday between Danbury and Southbury, Connecticut after the trailer flipped onto its side. There were no injuries.

The dump truck, owned by Norbert Mitchell Company and driven by Thomas Cyr, 49, was turning left from the off ramp of Interstate 84 when the incident happened, dumping the JLG boom, owned by United Rentals onto the ground, spilling fuel and oil.

The accident scene
