Alert!

Number 31, 28 January 2010

Elevated work platform (EWP) – RF causes controls to malfunction

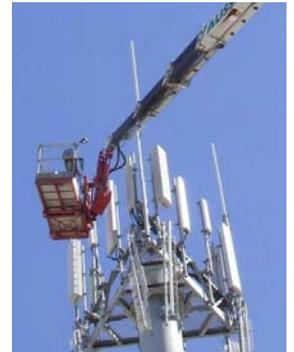
An incident occurred where a hired elevated work platform's electric controls malfunctioned due to EMI (electromagnetic interference) from nearby mobile base station antennas. EMI can also occur near other strong electromagnetic fields (EMFs), for example broadcasting towers, high voltage towers.

1. Check with the Hire Company whether the equipment has EMI shielding on electric controls and has emergency hydraulic controls. Units with mechanical (hydraulic) controls are not impacted.
2. Where the equipment may be impacted by EMI (where in doubt, assume equipment is impacted), ensure:
 - a. For radio sites, as much as possible that work is not undertaken inside strong EMFs by either
 - shutting-down or powering-down the RF transmitter for the relevant antenna sector; or
 - positioning away from the RF field (for example, work in areas under the public exposure limit for radio-frequency radiation, i.e., outside the yellow zone on radiation hazard drawings.
 - b. all team members can operate emergency controls to facilitate rescue in the event of failure of the controller.
