LG TRAVEL TOWER SERVICES PTY LTD.

Field bulletin FB 0001 “

30-11-2020.

Model number: GP14-300

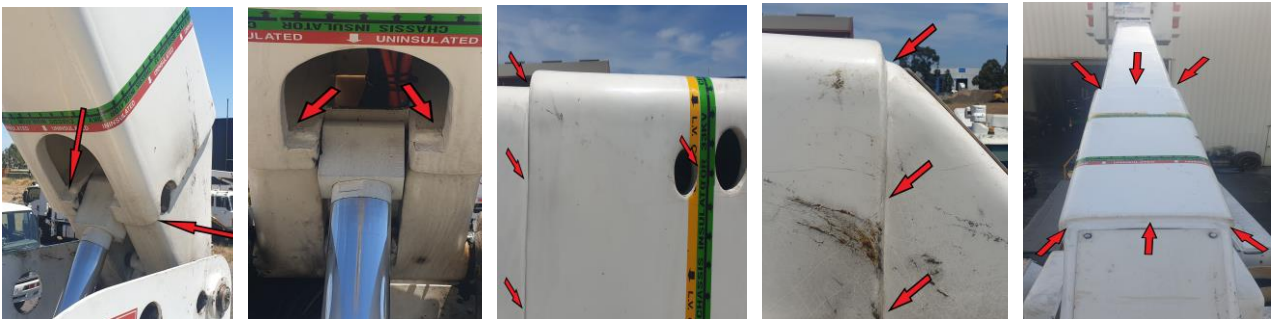
We have become aware of an incident involving an LG model GP14 that occurred in Western Australia last week. We have no information other than a press report which appears to indicate catastrophic failure on the lower boom insert in the vicinity of the lower boom cylinder connection. Our records indicate that this unit was 9 ½ years old.

As a precaution we request you conduct the following structural inspections:

1. At the end the lower boom insert on the top, the sides and underneath for any sign of cracking or movement or corrosion
2. On the interior for signs of corrosion and cracking.
3. Check for looseness in the insert by watching the boom during raising, lowering and slewing movements – placing the basket on its rest and then raise the boom.
